East Lake Sammamish Trail Inglewood Hill Road Parking Lot Project

Tree Inventory/Assessment Report

6/17/2017
Updated 7/7/17

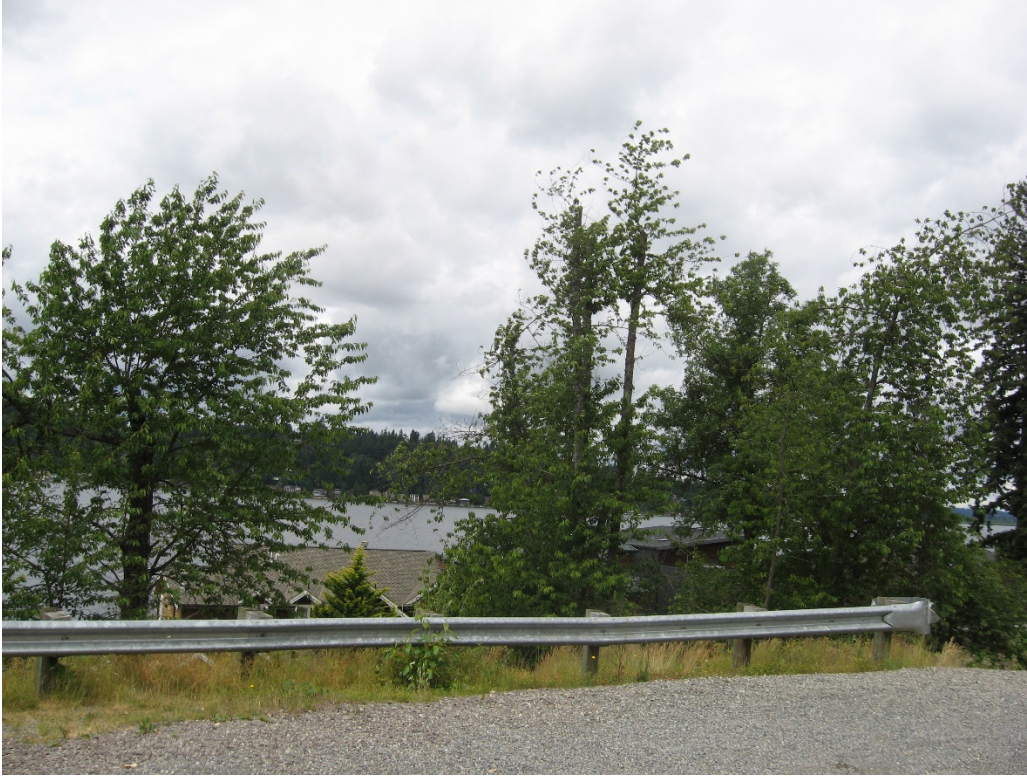
12 of the subject trees have been recently topped, likely to remove dead and or dying tops and to reduce hazard potential. These include #6000, #6001, #6002, #8035, #8036, #8037, #8038, #8039, #8040, #8041, #8042 and #8043. Topped heights range between 20’ and 40’. These will never develop a structurally sound form and are therefore rated as ‘poor’ condition

Subject Area – Trees #6000, #6001 and #6002 on right; Tree #8035 on left

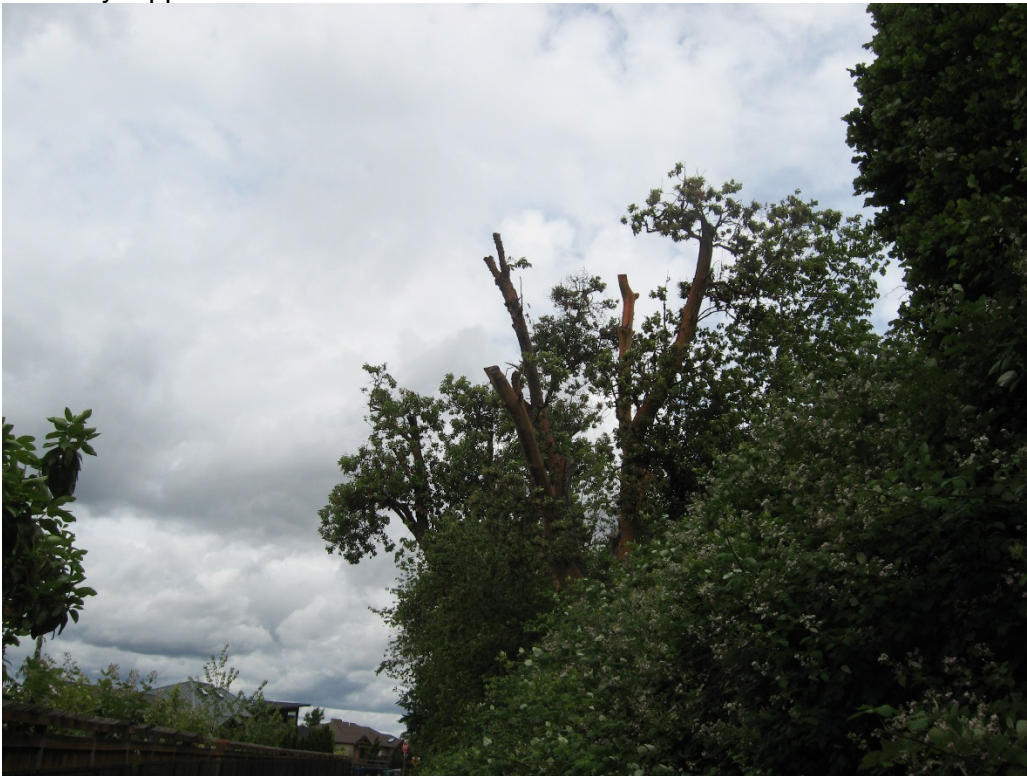
Recently topped trees #8036 > #8040

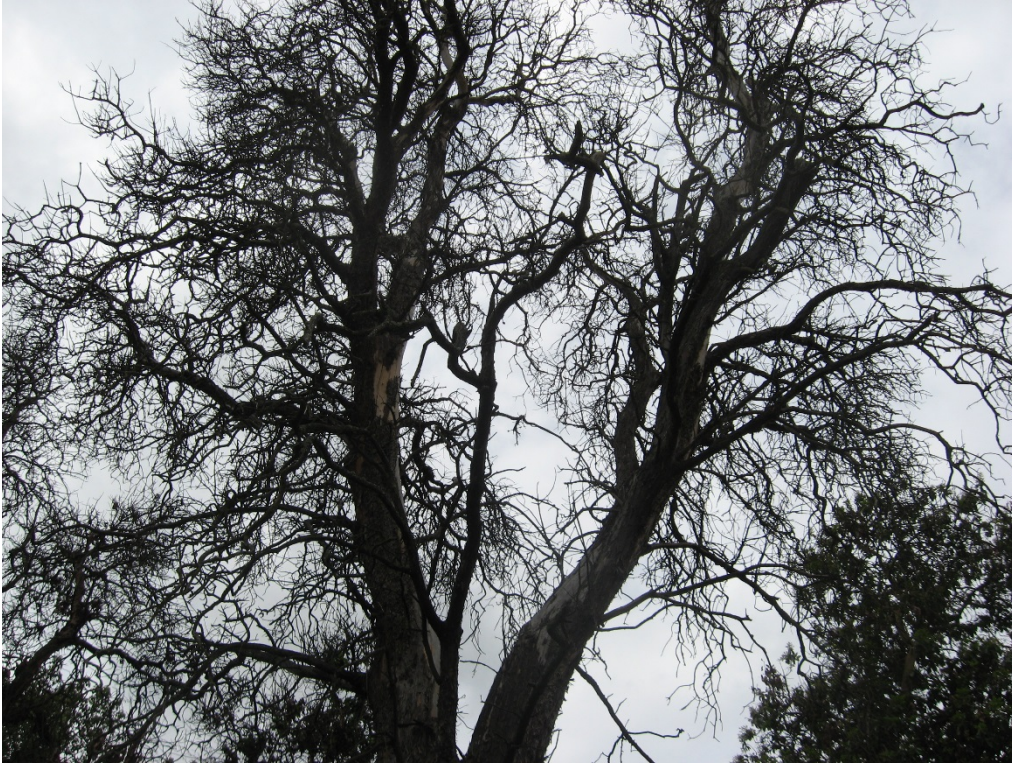
All of the subject Pacific madrone trees are diseased, infected with Madrone canker. These range from over 90% dead to incipient decline. The Pacific madrone has been in general decline across the Puget Sound Region for the past several years. This decline is mostly associated with the fungal diseases *Natrassia* and Madrone canker. Subject trees #8050, #8054 and #17508 are in the advanced stages of decline and have almost succumb to complete mortality.

Tree #17508 – over 90% dead

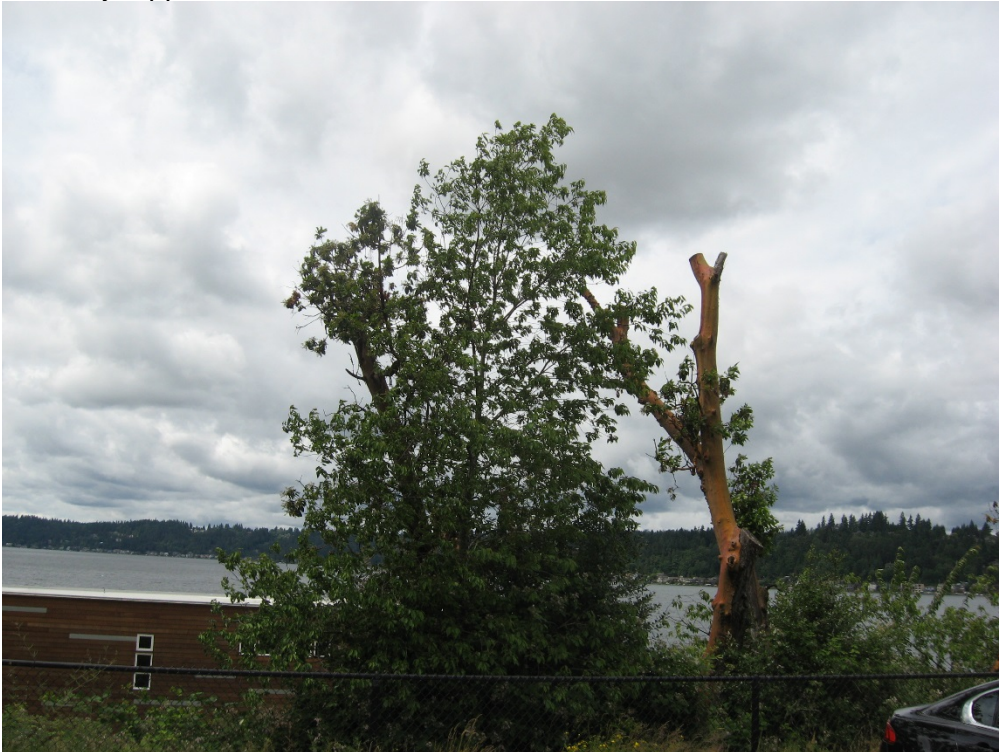
Recently topped trees #8042 and #8043

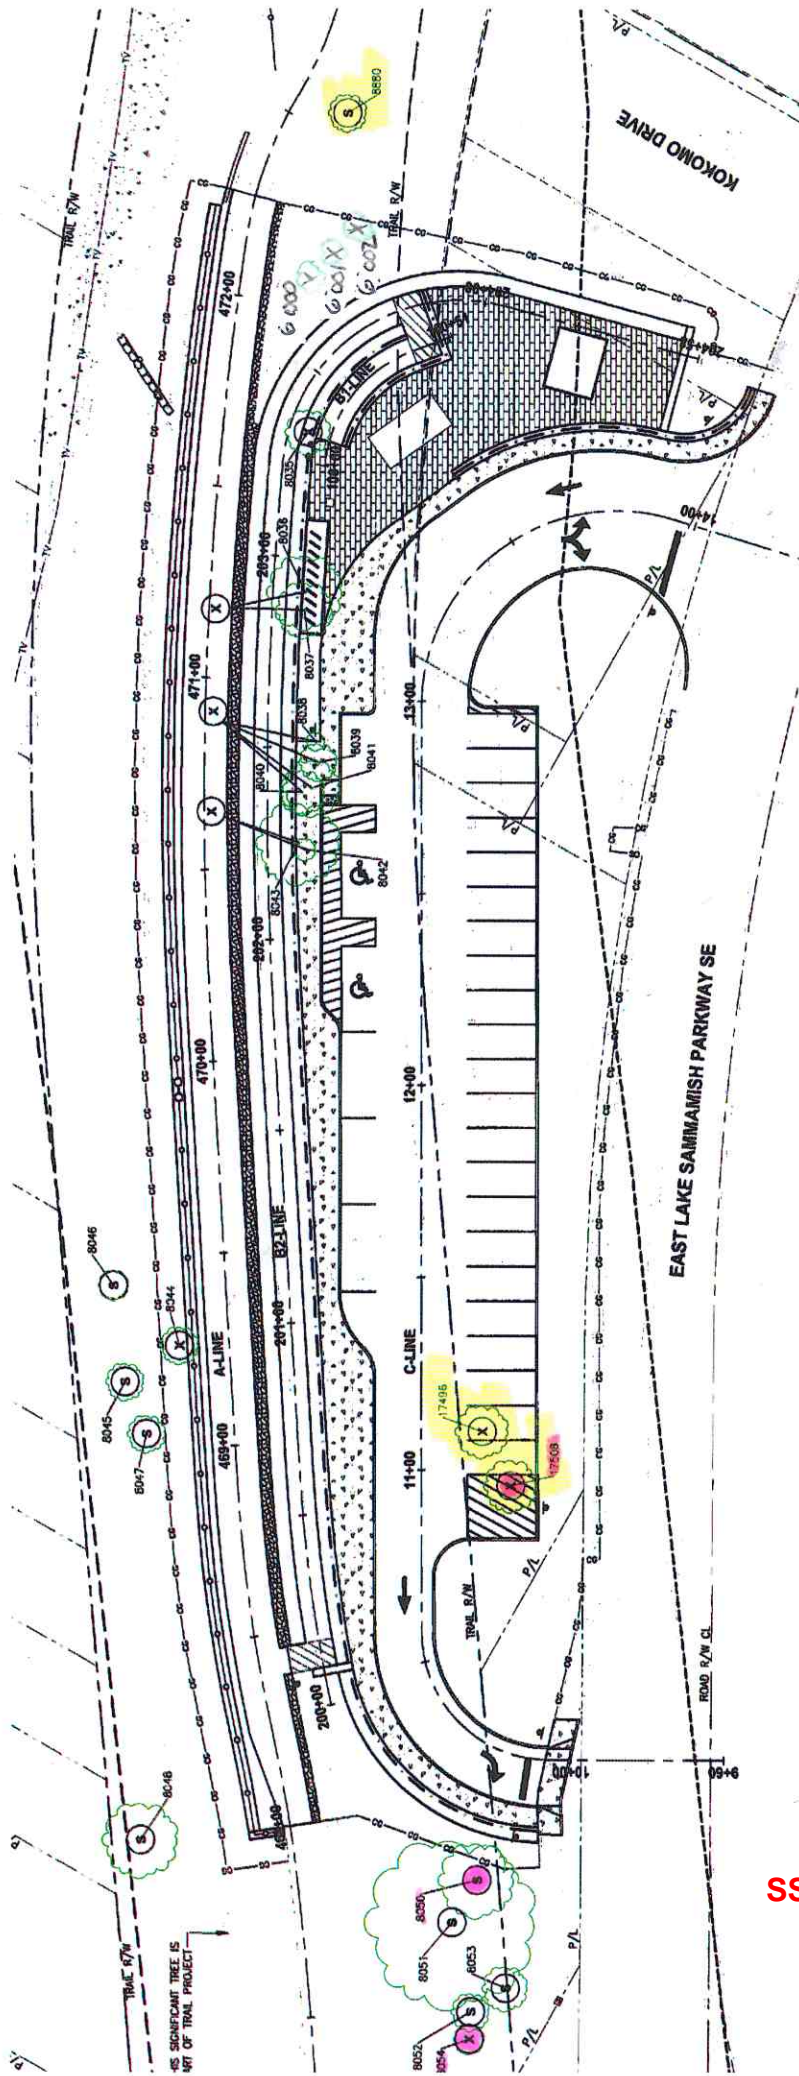
INGLEWOOD HILL ROAD - PARKING LOT PROTECT
SIGNIFICANT TREE ASSESSMENT

NOTES
 #6001, 6002, 8035, 8036, 8037, 8038, 8039, 8040, 8041, 8042, 8043 - ALL TOPPED IN RECENT PAST
 #8044 HAS BEEN REMOVED - NO LONGER EXISTS
 ● - INDICATES HAZARD TREE
