STATE OF WASHINGTON ARCHAEOLOGICAL SITE INVENTORY FORM

Compiled By: Sonja Kassa

Site Name: Hammersberg home and debris scatter

Site Type: Historic Debris Scatter/Concentration

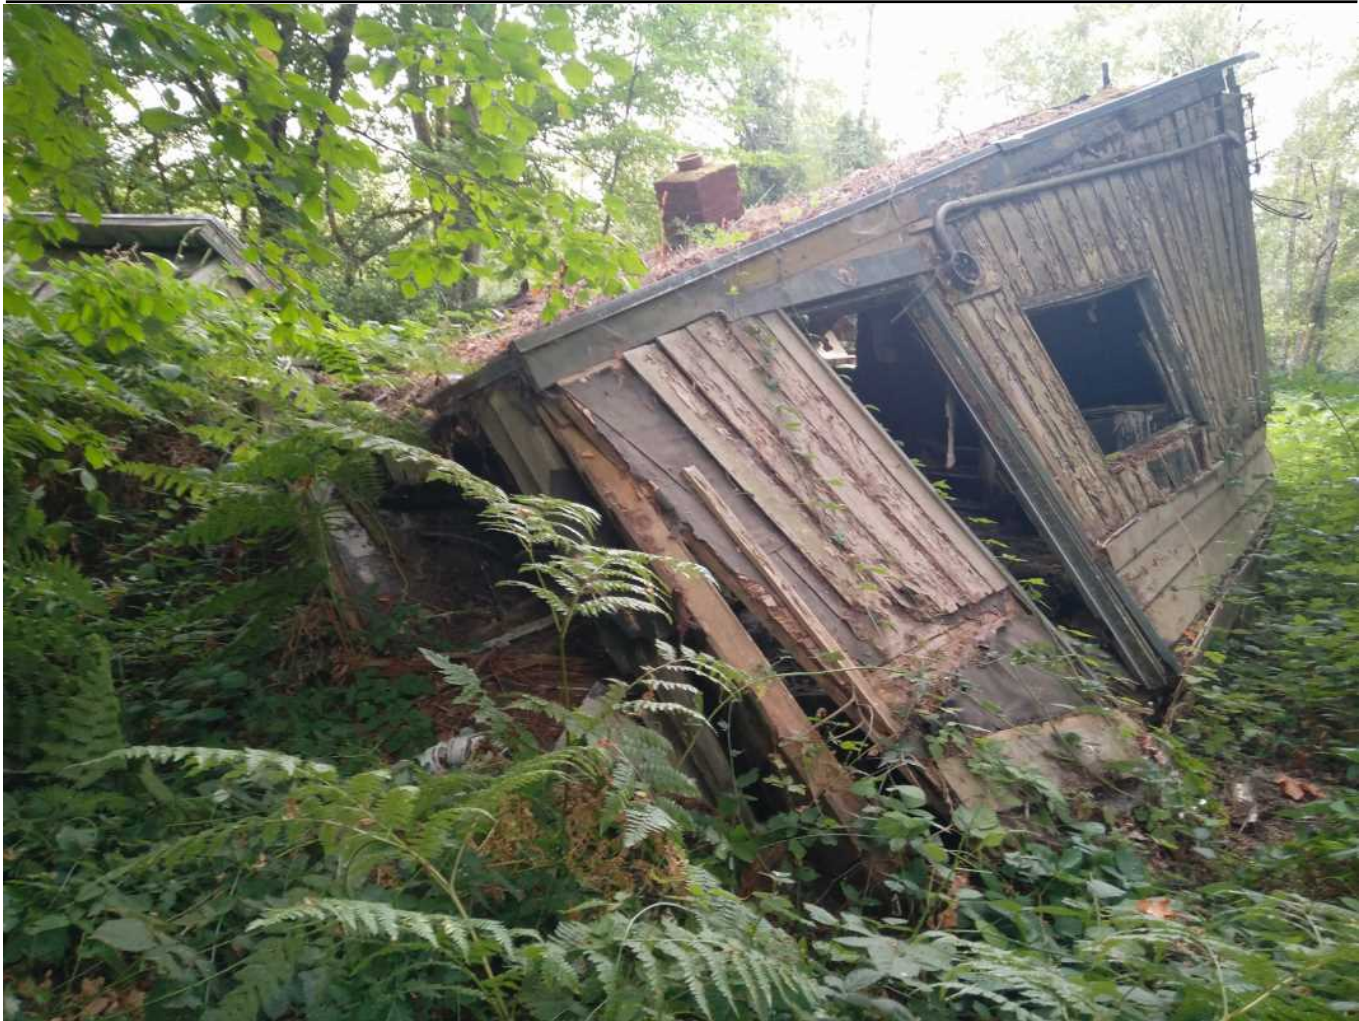
Photo ID 357576
Title single-family residence - entry
Year Taken 2017
Is Circa?
Notes
Type image/jpeg
Photo View view is to the southwest
Source
Copyright

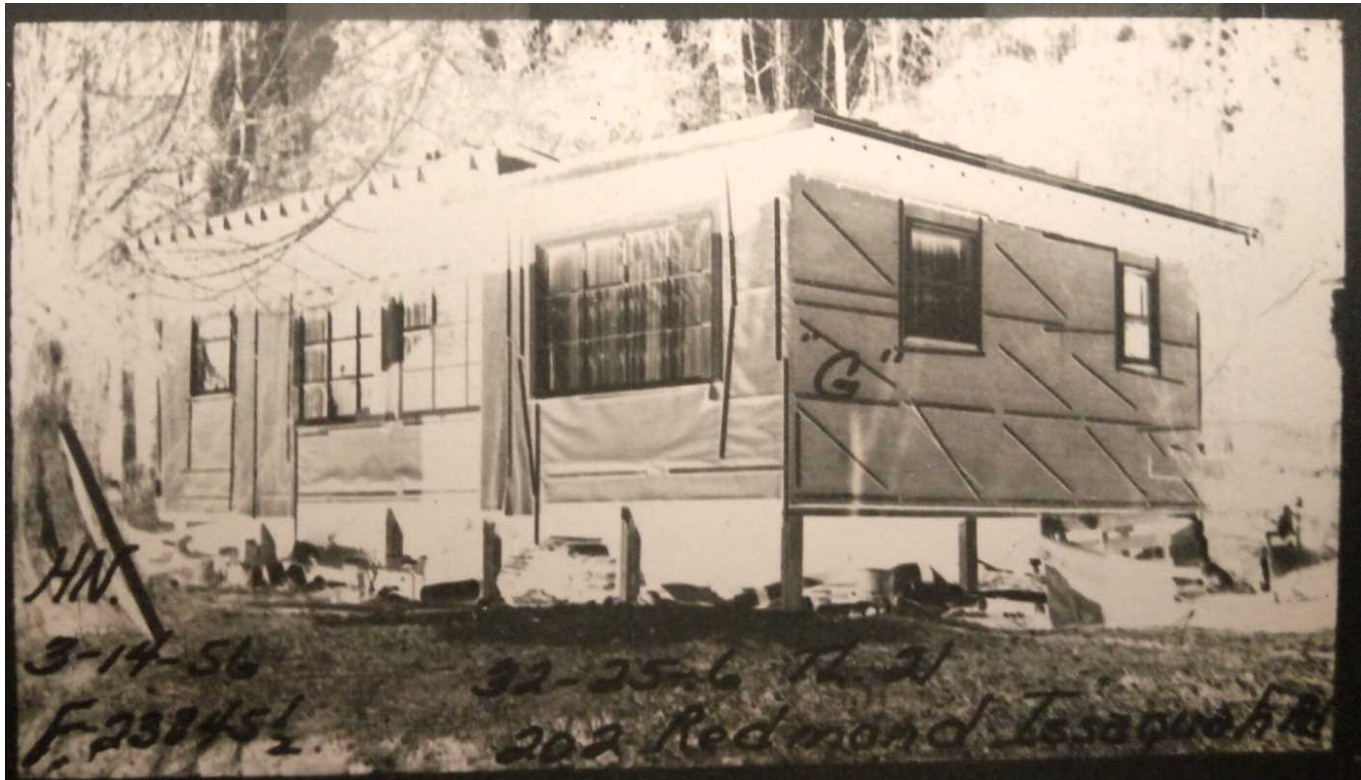
Photo ID 357604
Title single family residence 1956
Year Taken 1956
Is Circa?
Notes
Type image/jpeg
Photo View view is to the southeast
Source From Puget Sound Regional Archives
Copyright

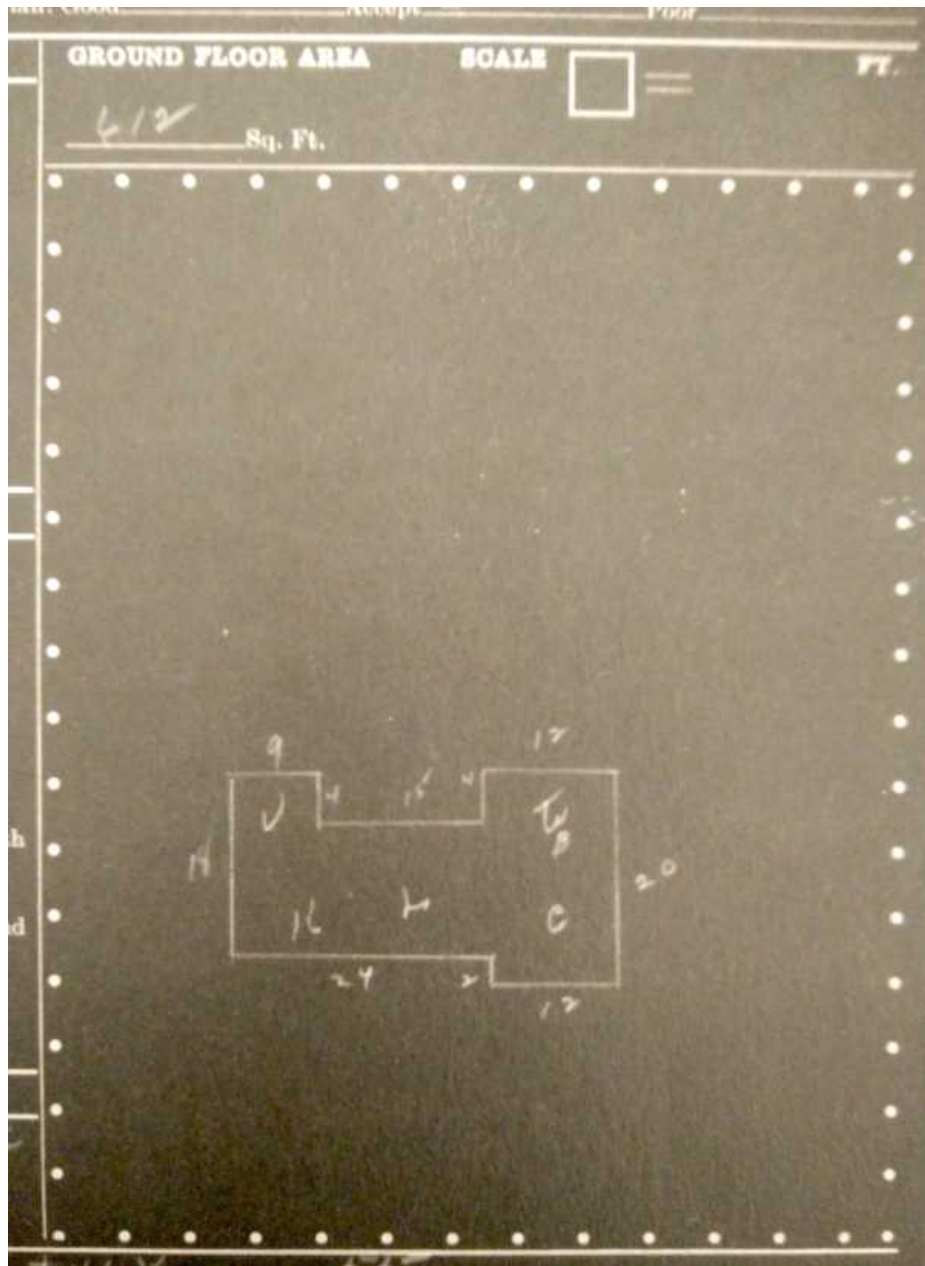
Photo ID 357603
Title single-family residence plans - tax assessor data 1954
Year Taken 2017
Is Circa?
Notes
Type image/jpeg
Photo View
Source From Puget Sound Regional Archives
Copyright

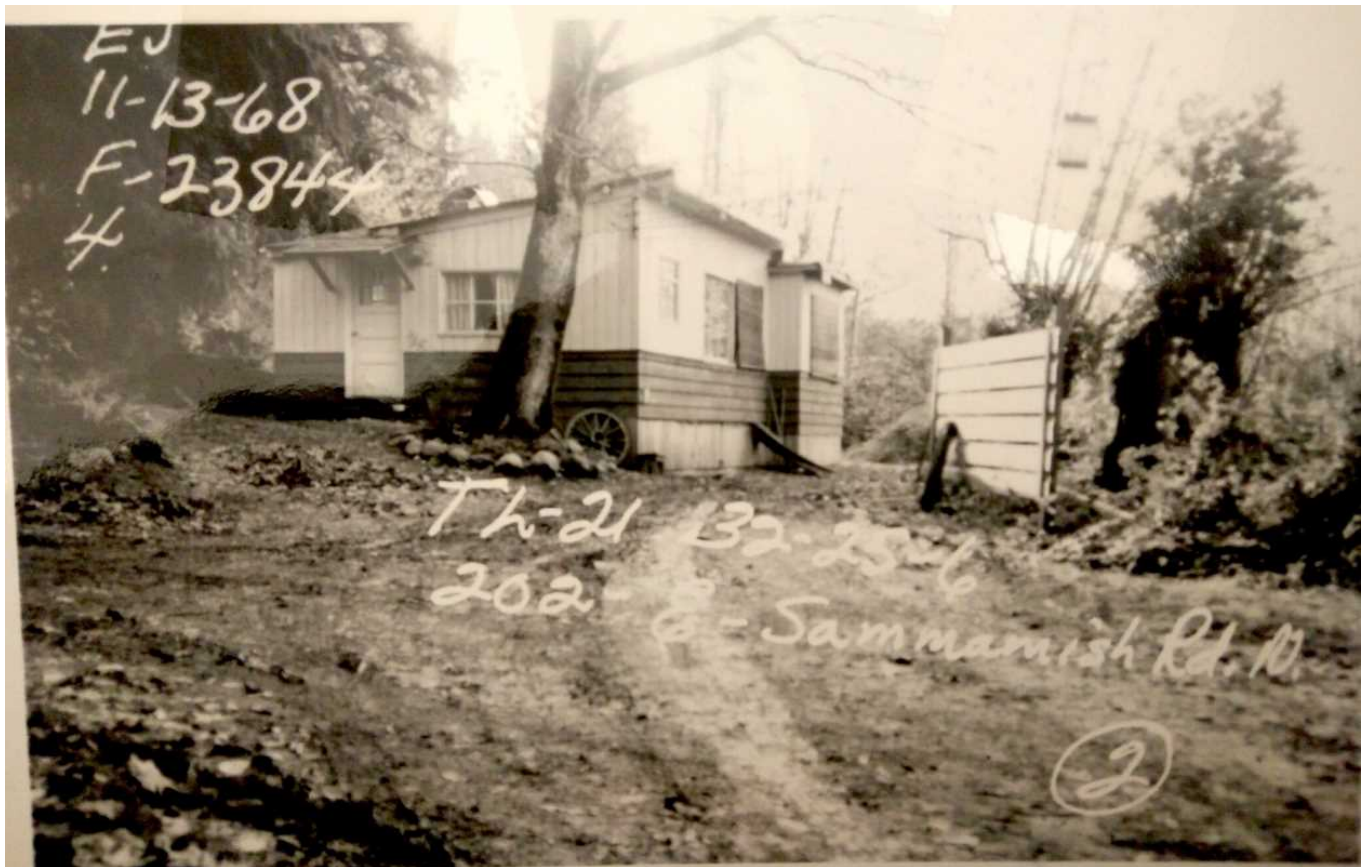
Photo ID 357601
Title single-family residence - tax assessor data 1954
Year Taken 1954
Is Circa?
Notes
Type image/jpeg
Photo View view is ot the south
Source From Puget Sound Regional Archives
Copyright

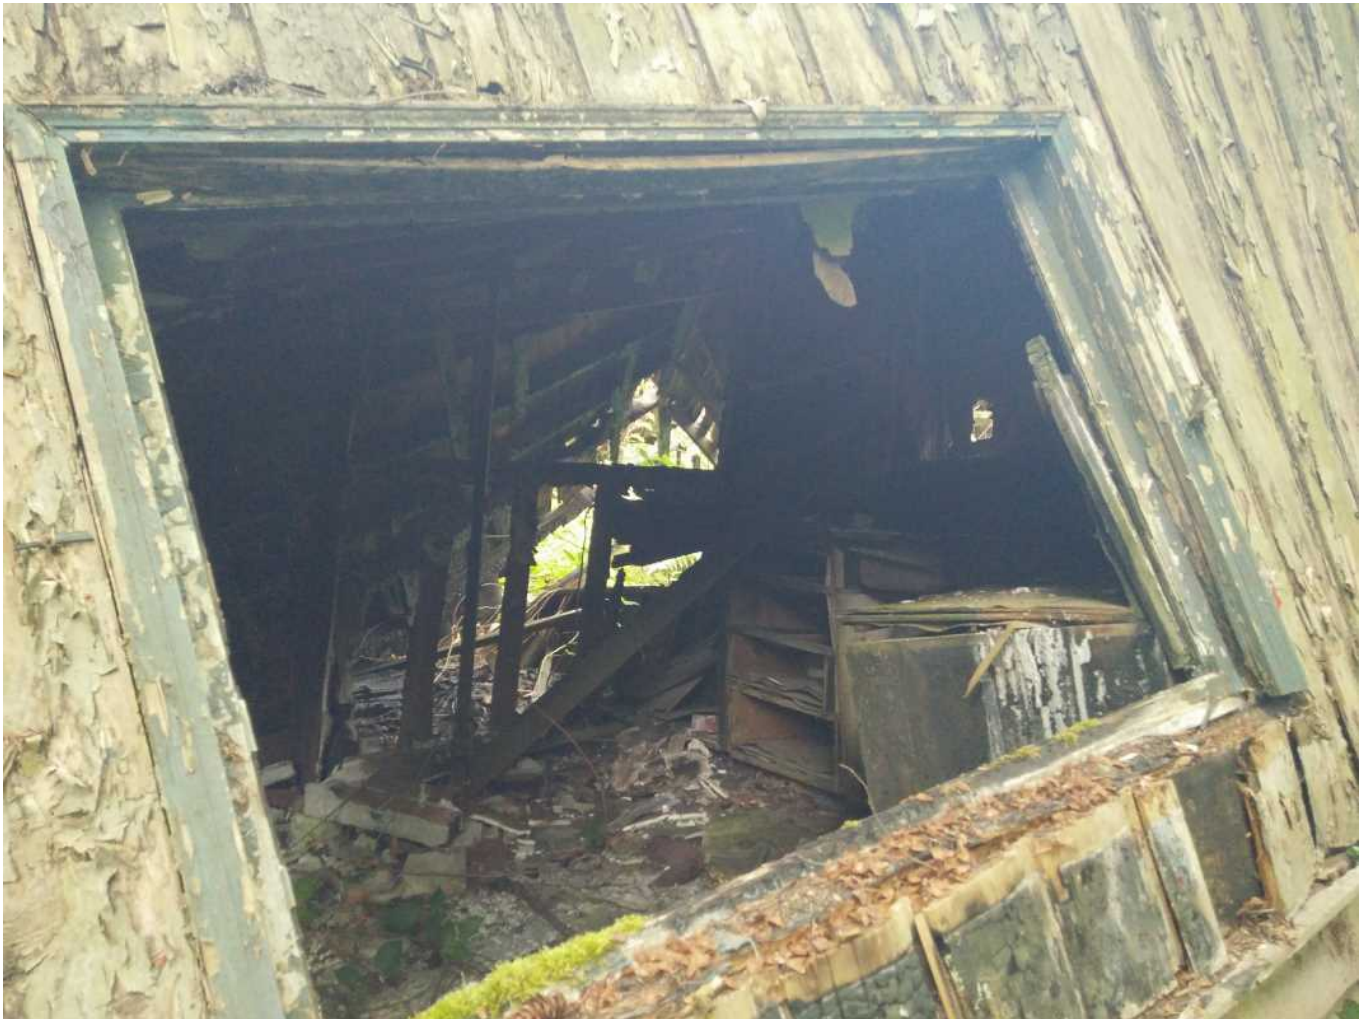
This site is a single-family residence that had suffered fire damage and was partially collapsed leaving its original appearance largely indistinguishable, though the following observations were made. It had vertical and horizontal wood siding in a double layer; a brick chimney was present on the center east side; a window and door were present on the north side; power was visible on the outside; a kitchen was present in the northwest corner; laminate flooring was visible; a small, L-shaped bathroom was present in the southeast corner with sea foam green fixtures; and non-diagnostic debris was present around the house.

Photo ID 357574
Title single-family residence - interior
Year Taken 2017
Is Circa?
Notes
Type image/jpeg
Photo View view is to the southwest
Source
Copyright

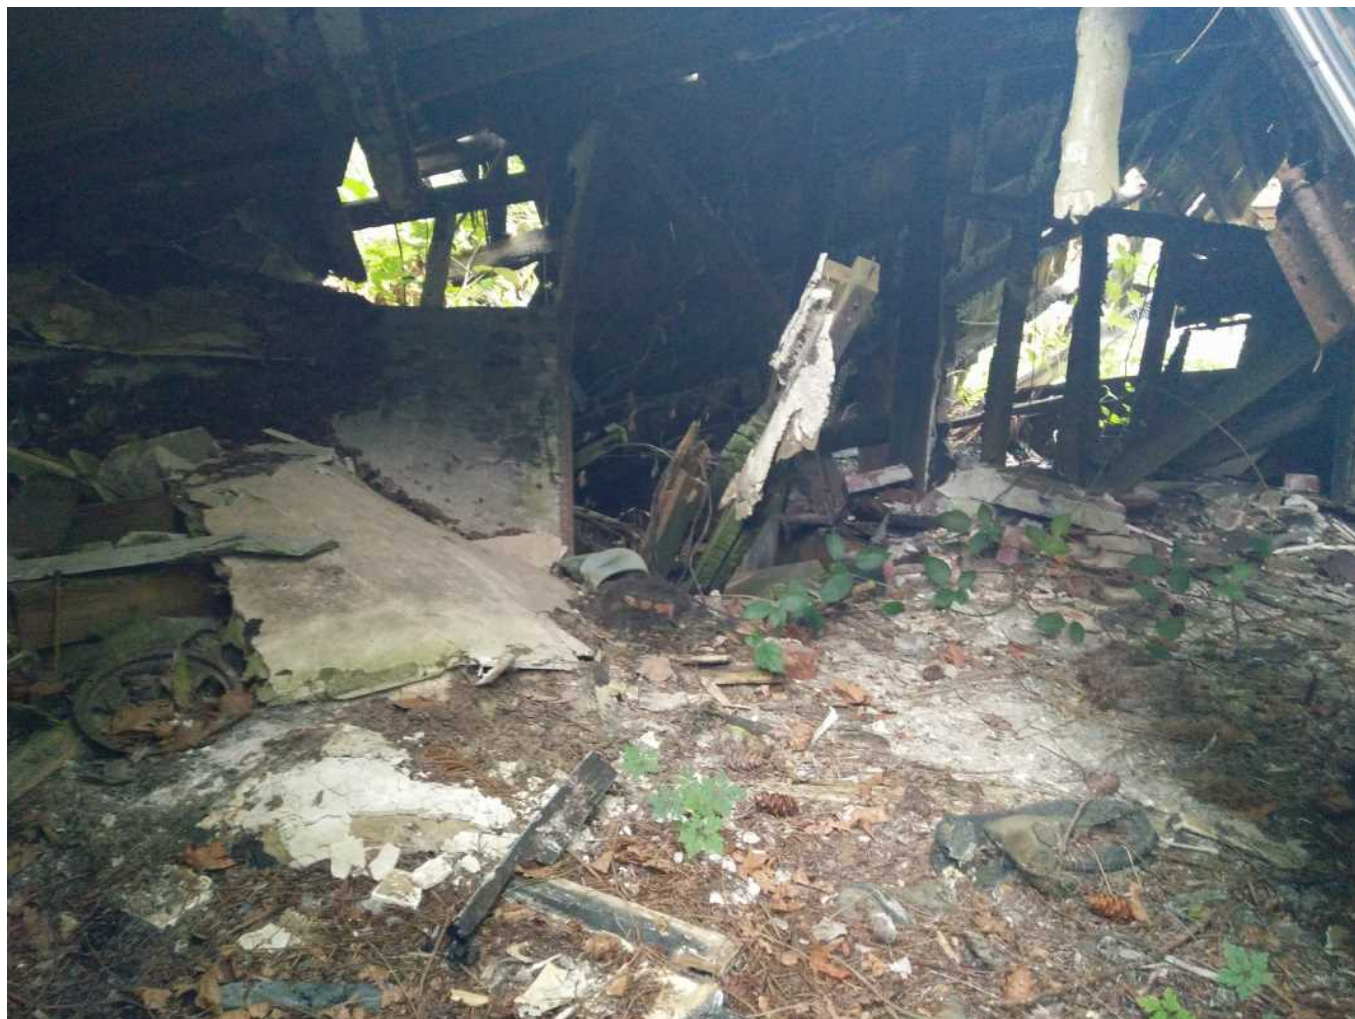
Photo ID 357572
Title single-family residence - interior
Year Taken 2017
Is Circa?
Notes
Type image/jpeg
Photo View view is to the south
Source
Copyright

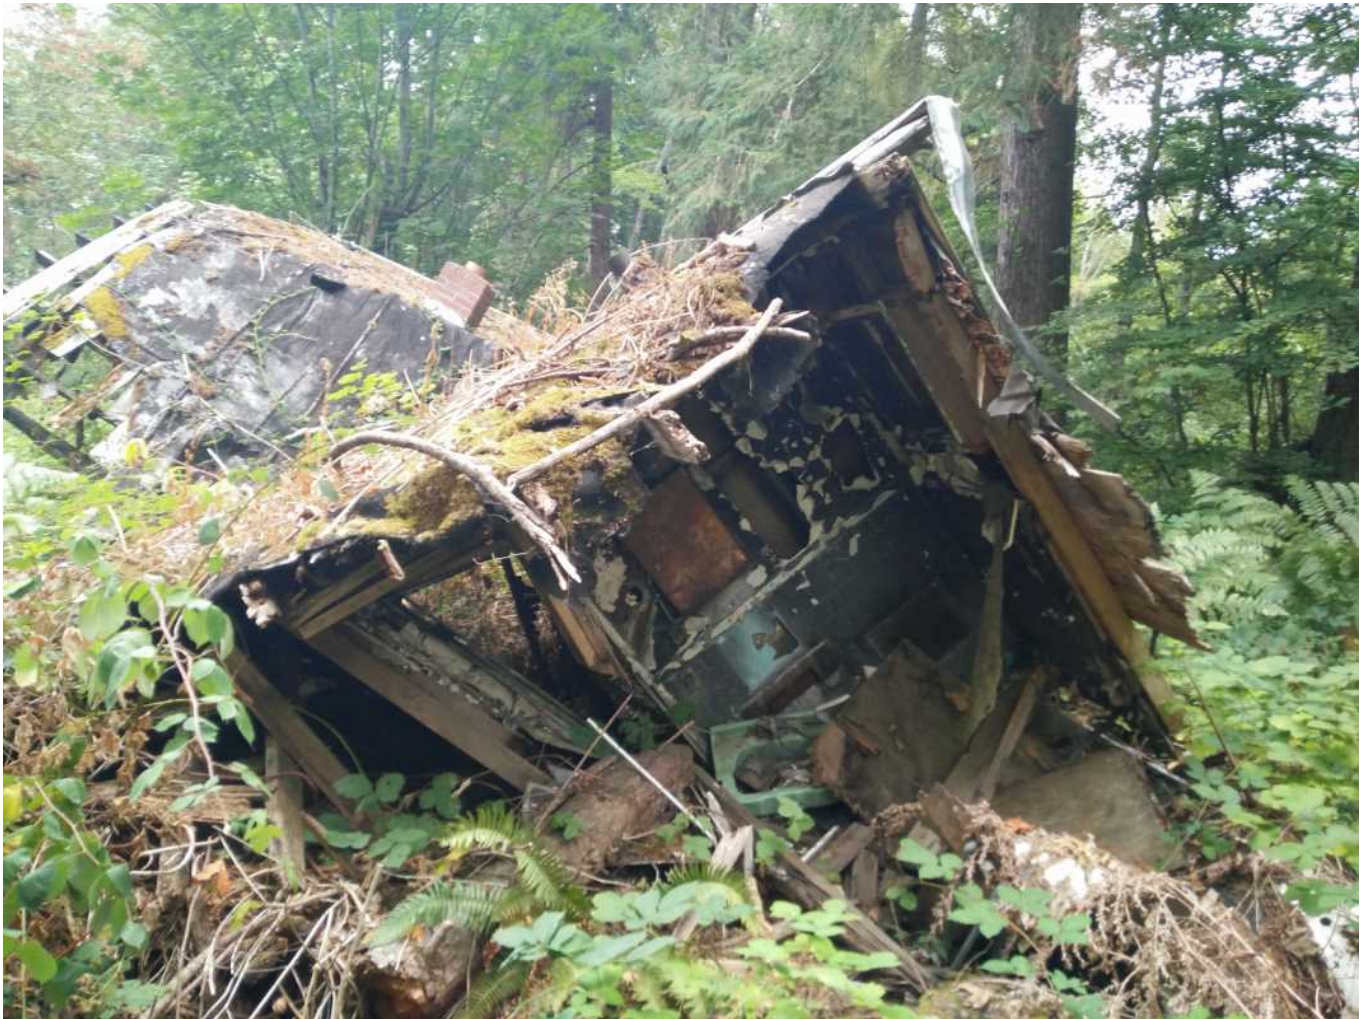
Photo ID 357571
Title single-family residence - exterior
Year Taken 2017
Is Circa?
Notes
Type image/jpeg
Photo View view is to the north
Source
Copyright

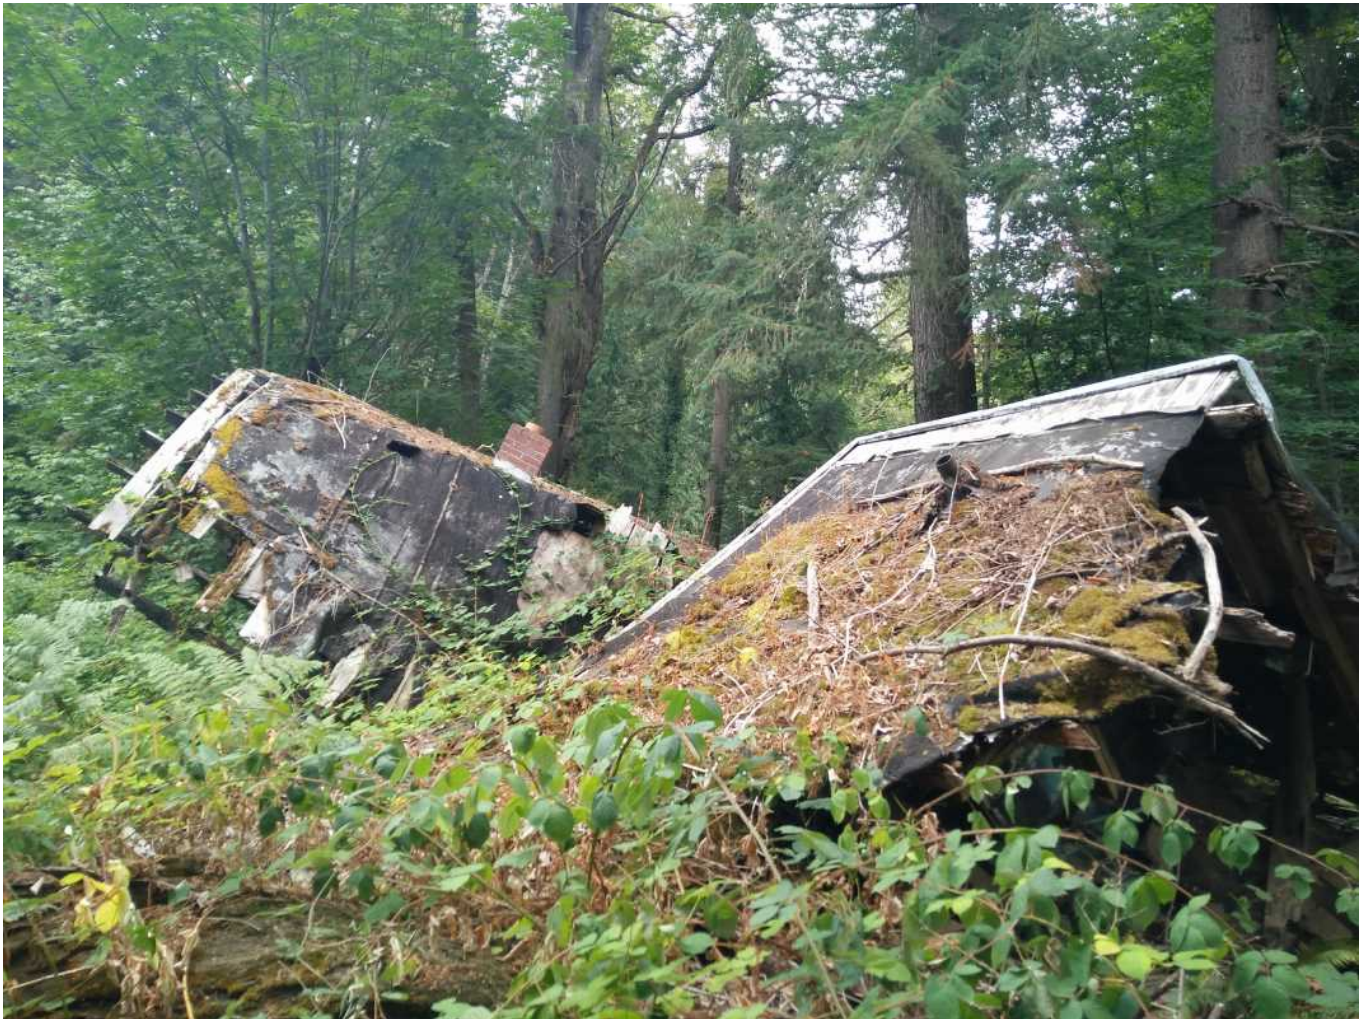
Photo ID 357570
Title single-family residence - exterior
Year Taken 2017
Is Circa?
Notes
Type image/jpeg
Photo View
Source
Copyright

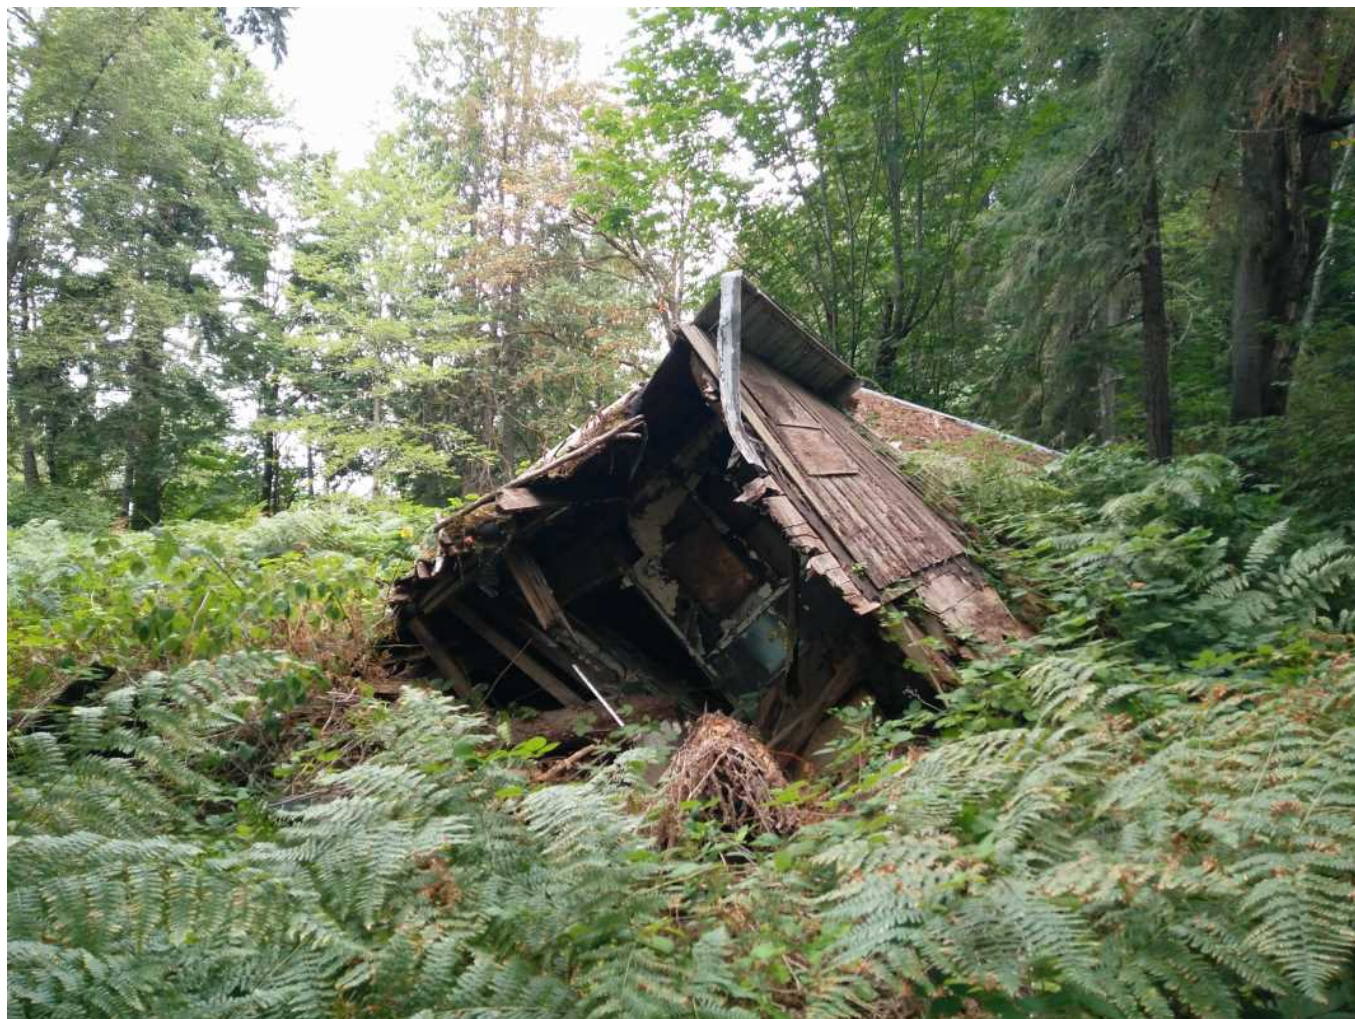
Photo ID 357568
Title single-family residence - south exterior
Year Taken 2017
Is Circa?
Notes
Type image/jpeg
Photo View view is to the north
Source
Copyright

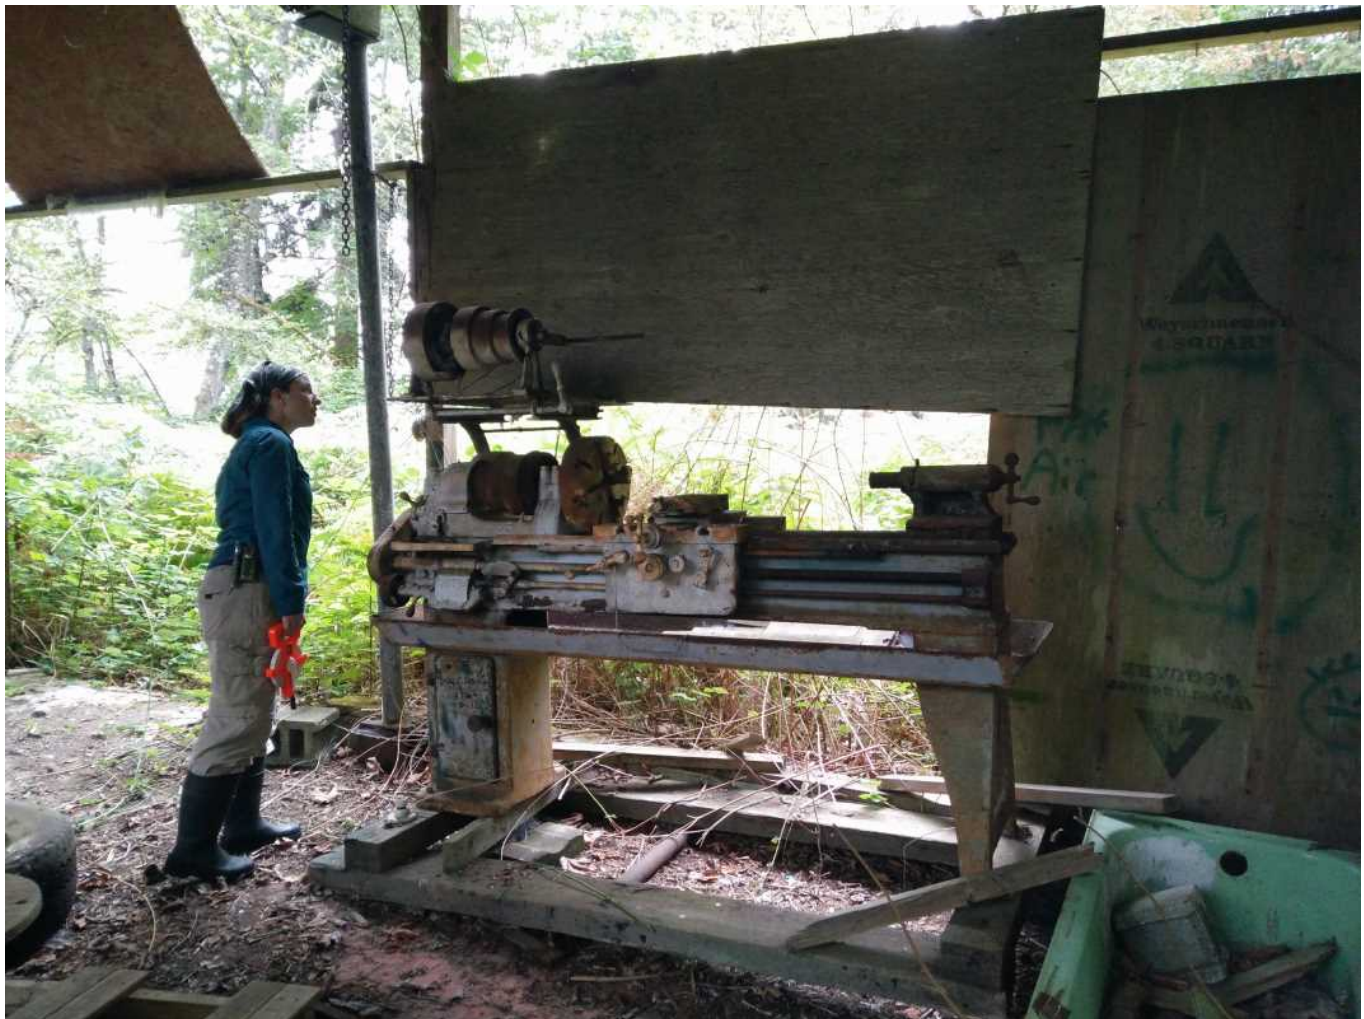
An outbuilding was present southwest of the residence and contained some salvaged items from the house fire, including the bath tub, it also contains a large lathe. The construction date of the outbuilding is unknown but it is associated with the residence. It was crudely built and can be considered condemned. It is primarily held up by poorly implemented joists and chains. It has a partial concreted floor, poured concrete and cinder block foundation. Three walls are no longer present or were removed by salvaging the wood. It is currently under stress from excessive vegetation growing on the roof.

Photo ID 357567
Title outbuilding - interior with lathe
Year Taken 2017
Is Circa?
Notes
Type image/jpeg
Photo View view is to the north
Source
Copyright

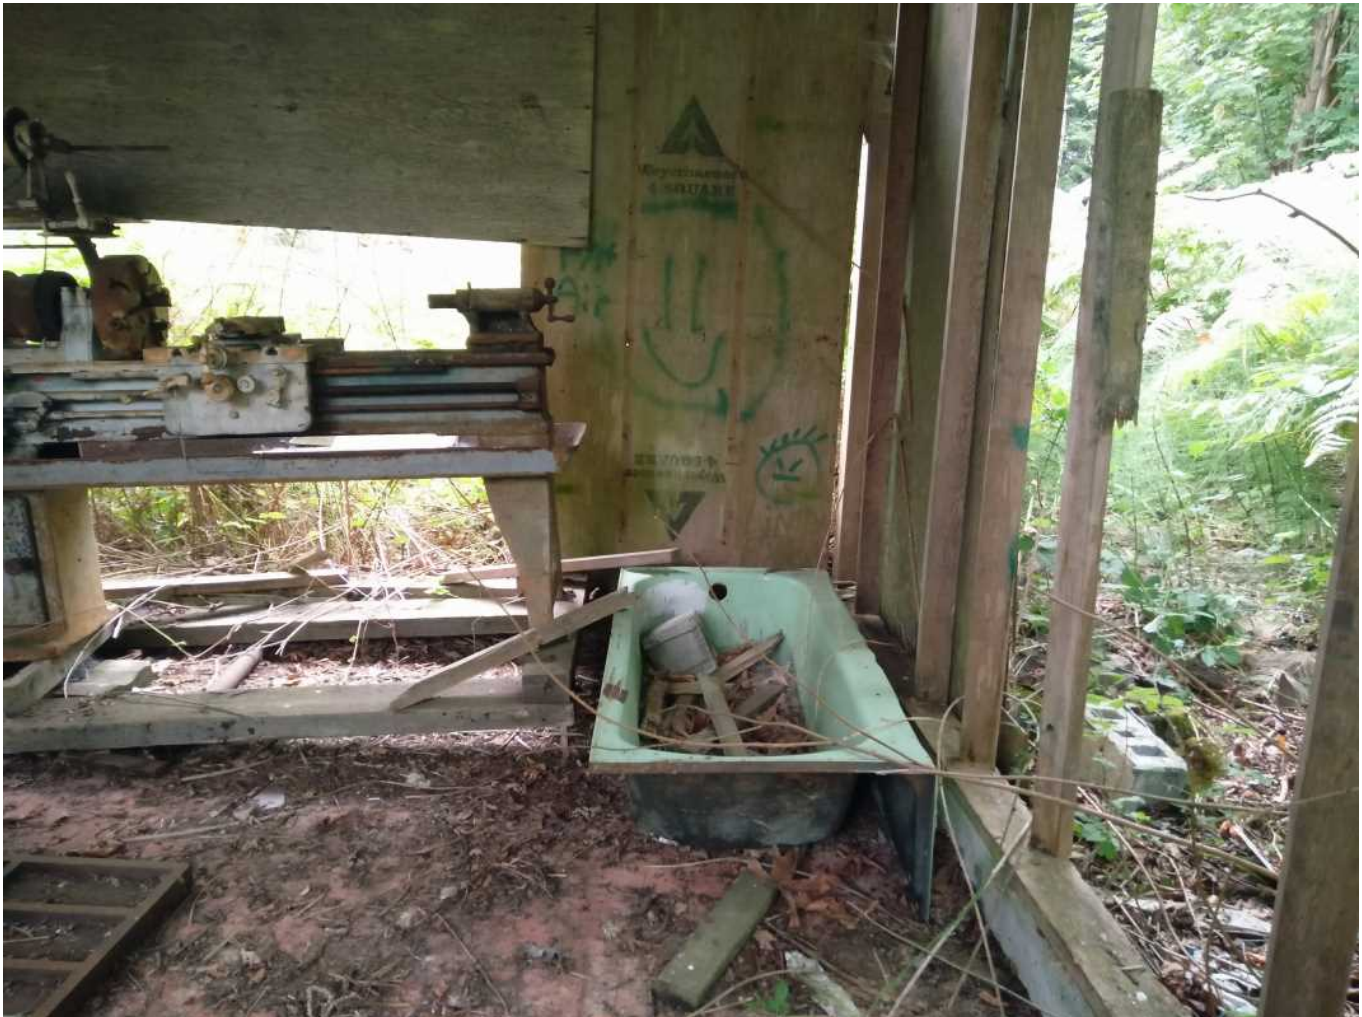
Photo ID 357566
Title outbuilding - interior with salvaged items from residence
Year Taken 2017
Is Circa?
Notes
Type image/jpeg
Photo View view is to the north
Source
Copyright

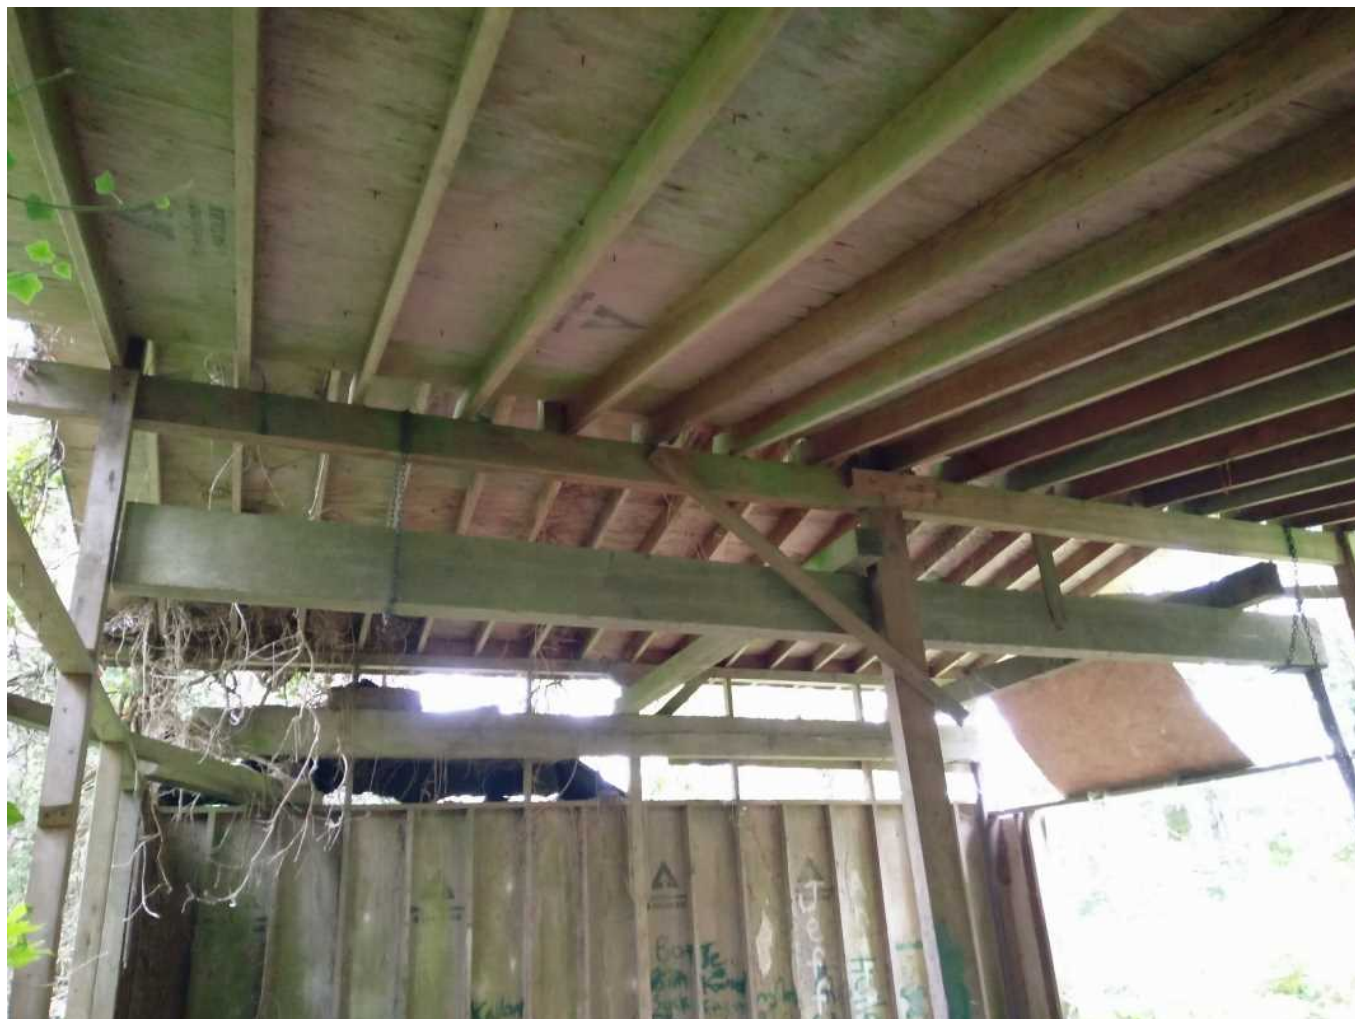
Photo ID 357565
Title outbuilding - interior
Year Taken 2017
Is Circa?
Notes
Type image/jpeg
Photo View
Source
Copyright

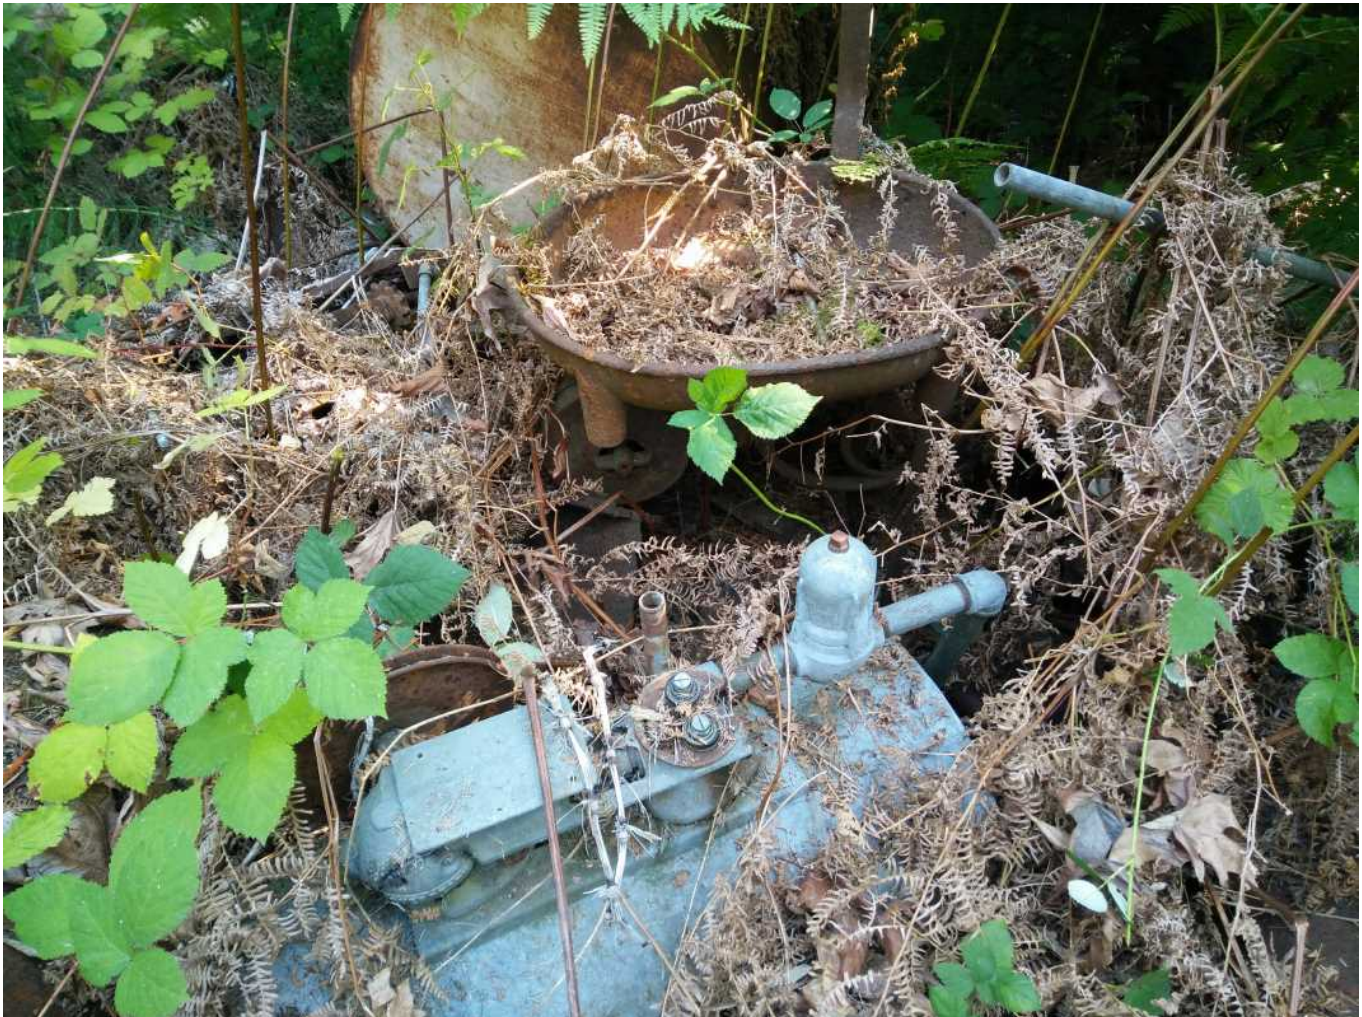
Two primary debris piles were visible west of the residence and partially obscured by dense vegetation. The first contained two rusted oil drums. The second was larger in size and contained a variety of pipes, machinery, and appliances, all rusted. Recognizable objects included a compressor and a radiator.

Photo ID 357564
Title debris pile - machinery
Year Taken 2017
Is Circa?
Notes
Type image/jpeg
Photo View view is to the east
Source
Copyright

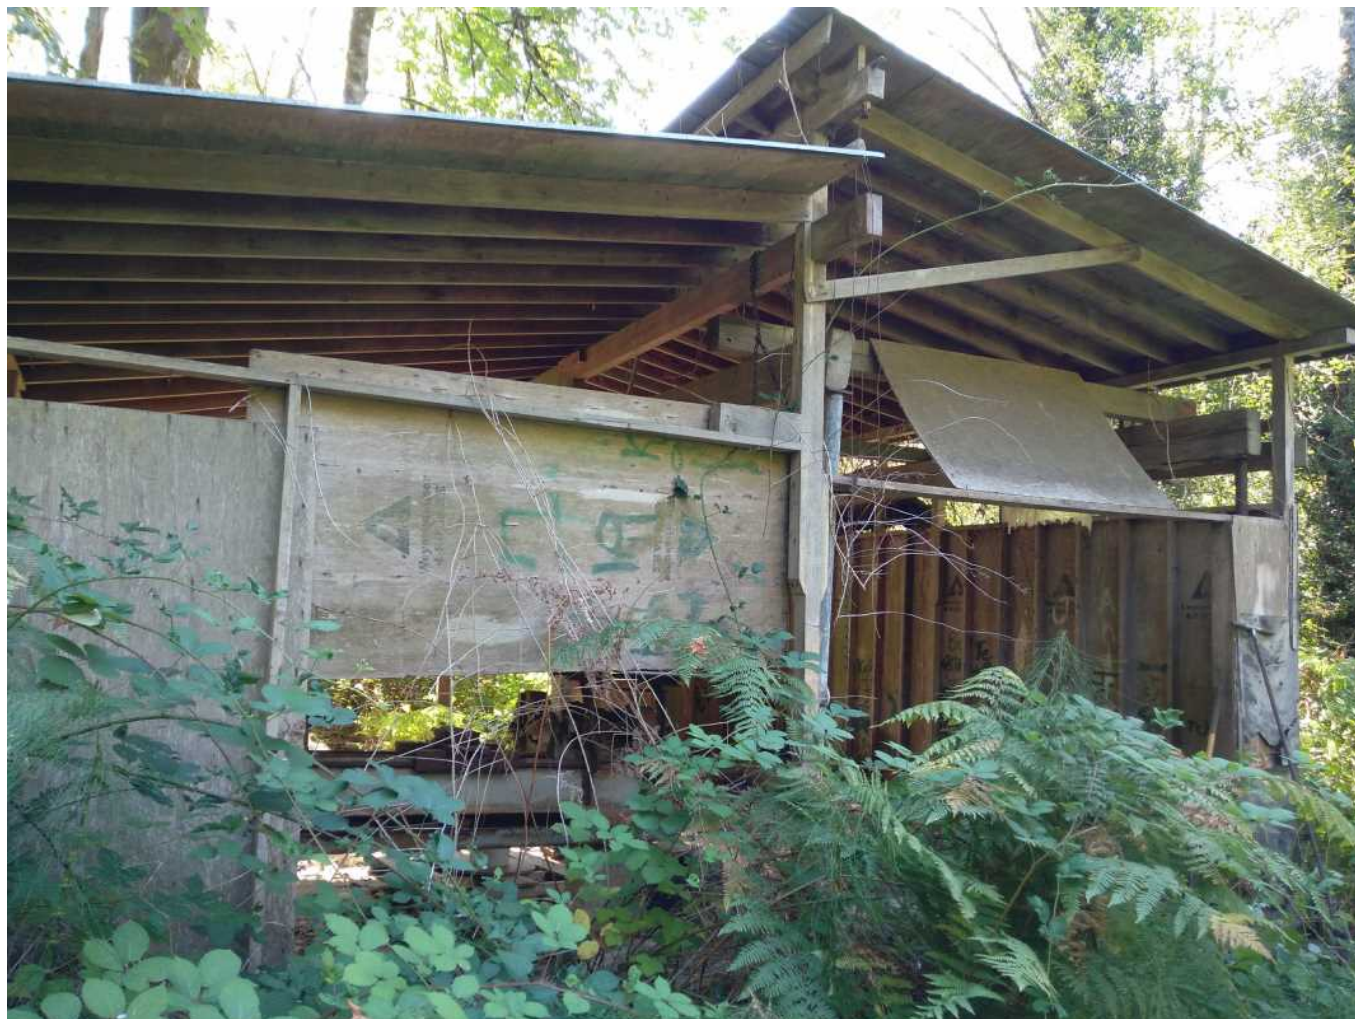
Photo ID 357563
Title outbuilding - exterior
Year Taken 2017
Is Circa?
Notes
Type image/jpeg
Photo View
Source
Copyright

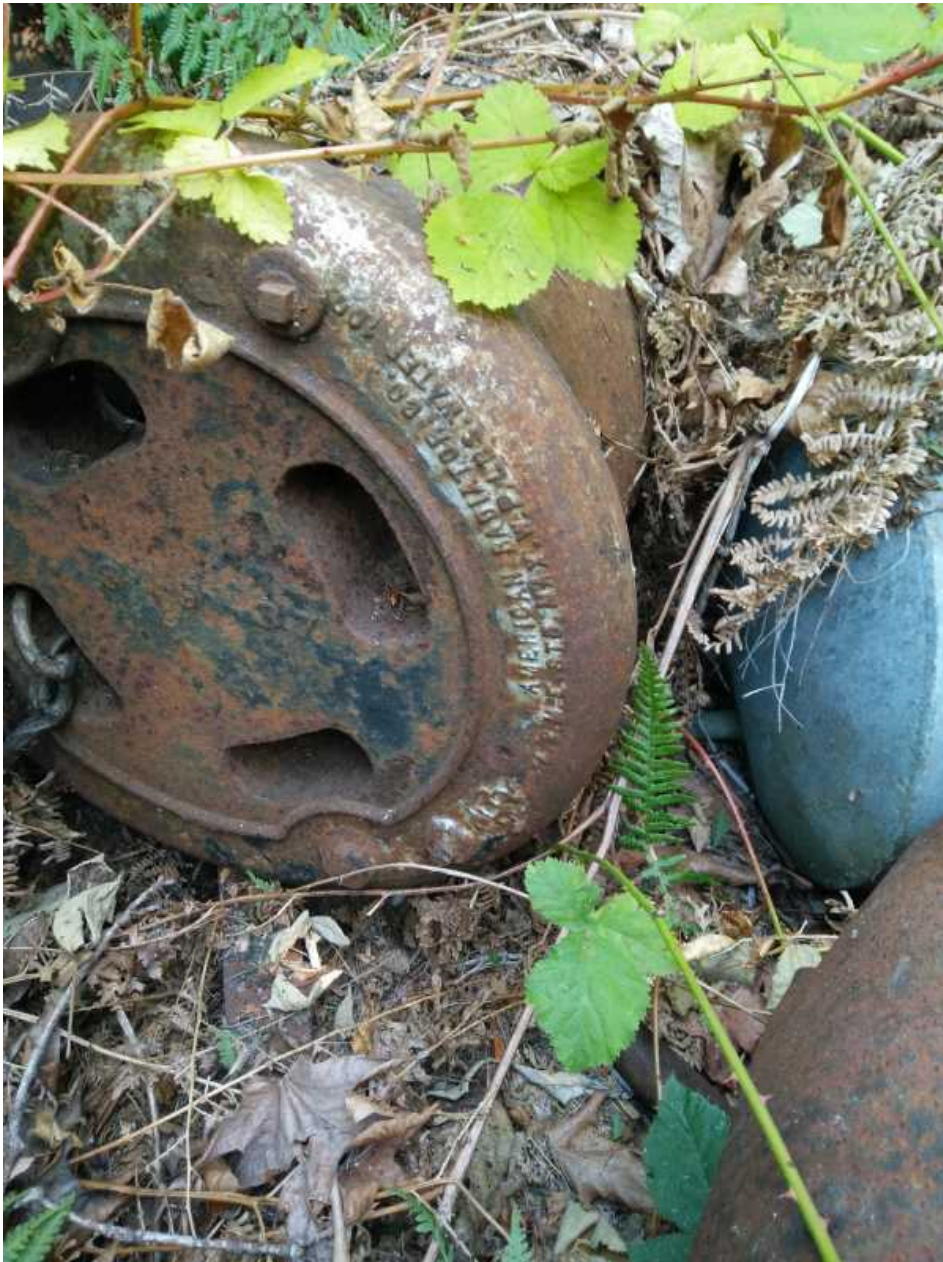
Photo ID 357562
Title debris pile
Year Taken 2017
Is Circa?
Notes
Type image/jpeg
Photo View
Source
Copyright

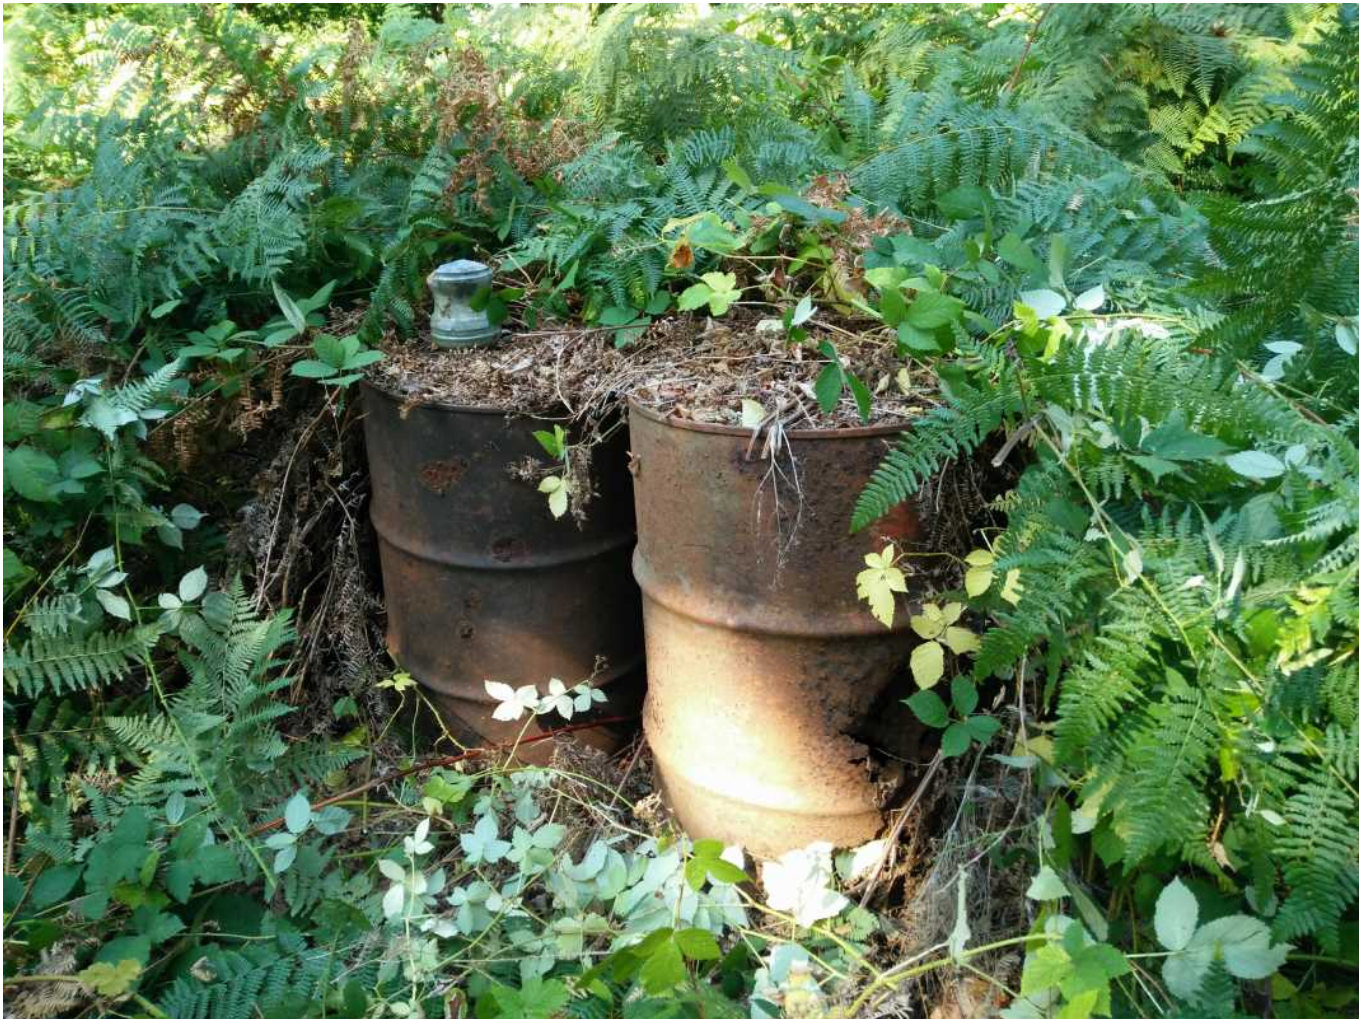
Photo ID 357561
Title rusted oil drums
Year Taken 2017
Is Circa?
Notes
Type image/jpeg
Photo View view is to the northwest
Source
Copyright
