# **Purpose and Background**

Zackuse Basin Plan was completed in 2019 and Laughing Jacobs was completed in 2022. This plan, the Pine Lake Creek Basin Plan, is the fifth and one of the last large basins with a primary creek system in the city to be evaluated. The remaining basins to be updated include Beaver Lake (not included in Laughing Jacobs Basin Plan), and the Monohon and Panhandle basins, which both include multiple small tributaries that flow directly to Lake Sammamish from

#### **Pine Lake Creek Basin Overview**

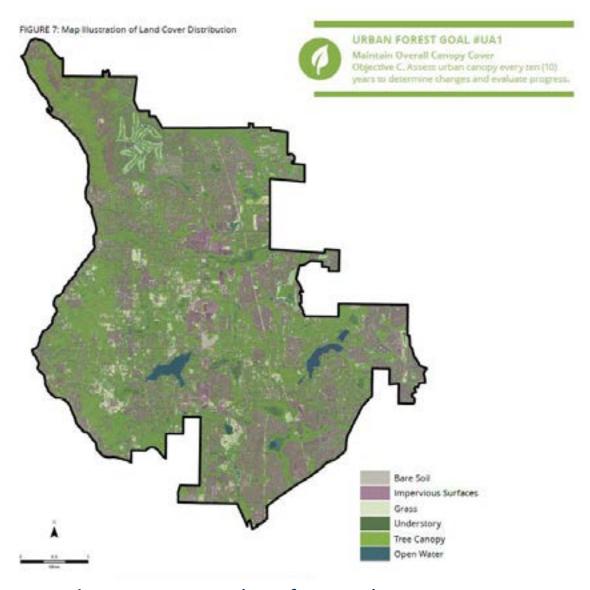
The City's Urban Forest Management Plan, adopted in November 2019, describes the forest composition and coverage of Sammamish's urban forest (City of Sammamish, 2019). The Pine Lake Creek Basin has one of the largest contiguous areas of tree canopy in Sammamish, with approximately 49% tree canopy, of which 50% is coniferous. One of the city's urban forest goal's is to maintain overall canopy cover (Urban Forest Goal #UA1). Figure 4-1 is a screenshot from the Urban Forest Management Plan (City of Sammamish, 2019) that shows the tree canopy in Pine Lake Creek Basin. Tree canopy helps keep water temperatures cooler, provides wood recruitment to channels, and promotes ecological activity good for fish and wildlife.

Figure 4-1. Screenshot of 2019 Urban Forestry Management Plan showing tree canopy

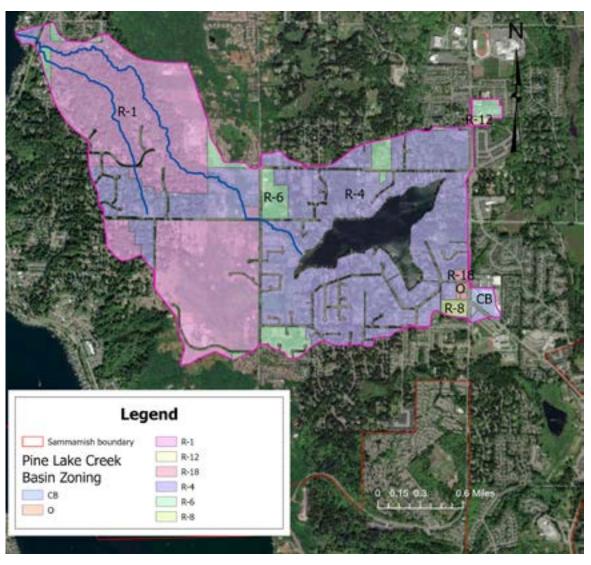
Figure 4-2. Pine Lake Creek Zoning

The built landscape in the Pine Lake Creek Basin is the result of 2024 and historical Sammamish zoning, development regulations, and economic factors. Figure 4-2

shows the current zoning in the basin. Over 92% of the basin is zoned R-1 (1 dwelling unit per acre) or R-4 (4 dwelling units per acre). There is a very small percentage of the basin that fronts SE 228th Street zoned at higher levels of multi-family and commercial levels, and a few pockets of R-6 zoning. In addition to the zoning, there are areas that are unlikely to be developed to the maximum extent in the zoning classification due to the presence of environmentally critical areas, such as forested steep slopes and wetlands. The lack of dense development in some areas of the basin, particularly in the stream corridors, provides for healthier forests and riparian areas that are beneficial for surface water resources. Although the city owns over 25 parcels in the basin, only one is in the undeveloped riparian corridor. The parcel contains Kanim Creek, downstream of SE 19th Street.

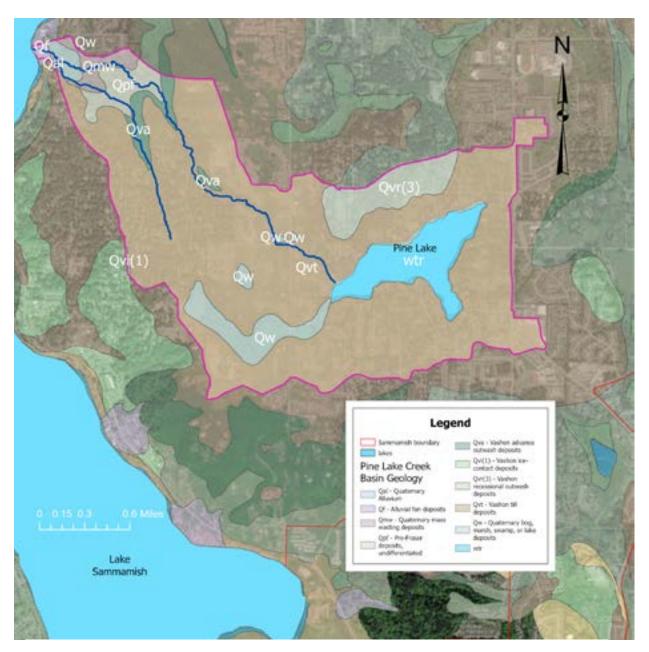
Figure 4-3. Pine Lake Creek Surficial Geology

- Wetlands, which are typically peaty;
- · Loamy soil deposits on top of the till;
- Alluvium and alluvial fan deposits near the lake formed by streams;
- Mass wasting from slope failures;
- Older glacial deposits that are typically fine-grained;
- · Very low permeability clay beneath the sandy outwash; and
- Recessional outwash deposited on top of the glacial till.

These geologic units contribute to the stream and hillslope geomorphic conditions present in the Pine Lake Creek basin and also impact the potential for stormwater infiltration. A more thorough description of the local geology is provided in the Preliminary Stormwater Feasibility Evaluation memorandum in Appendix E.

The best potential for shallow infiltration appears to be in the zone of recessional outwash (Qvr(3)), north of Pine Lake.

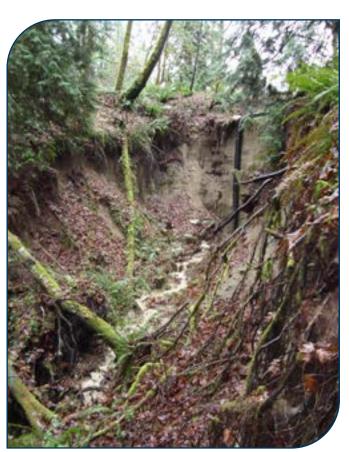
Stream and hillslope conditions adjacent to the stream channels were observed during site visits. In the Kanim Creek Basin, unstable slopes were observed in the sandy advance outwash deposits on the ravine walls. Active landslides were observed, as well as likely historical slide areas apparent on LiDAR (light detection and ranging) imagery, a remote sensing method used to identify relative elevations. Sand deposits from these unstable slopes were observed on the valley floor, with the stream channel cutting through the material in a braided fashion before re-forming a single-thread channel. Stream channel erosion (downcutting) was observed in the upper reaches of Kanim Creek. In the

Kanim Creek Landslide

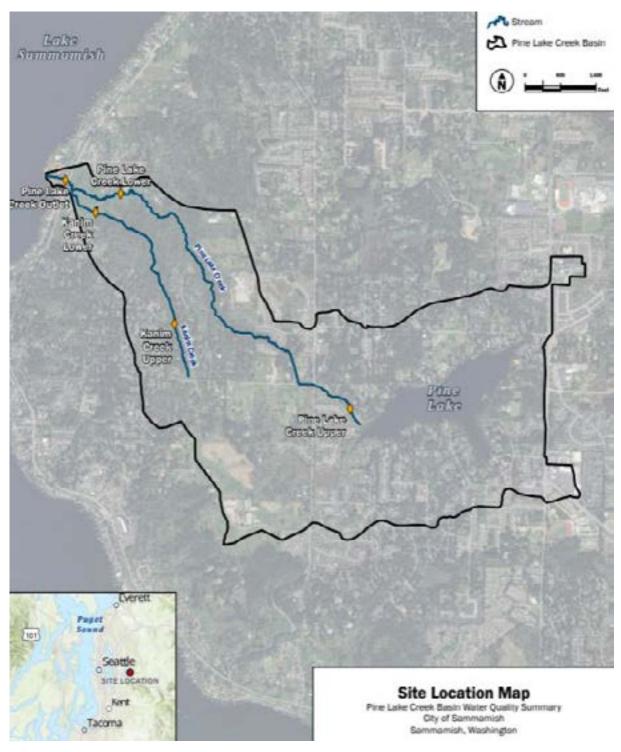
Figure 4-4. Water Quality Monitoring Locations

Supplemental water quality and flow data was collected for this project to understand existing water quality conditions in the creeks at five locations. Figure 4-4 show the locations of the water quality monitoring stations. As is typical in western Washington streams, flow data show that flow in both creeks is higher during the winter and gradually decreases through the summer dry seasons. The water quality results show signs of relatively good health (turbidity, nitrogen, TSS, and pH) and some of potential concern (dissolved oxygen and fecal coliform). The limited water quality results showed consistency at each sampling site at different flows and seasons.

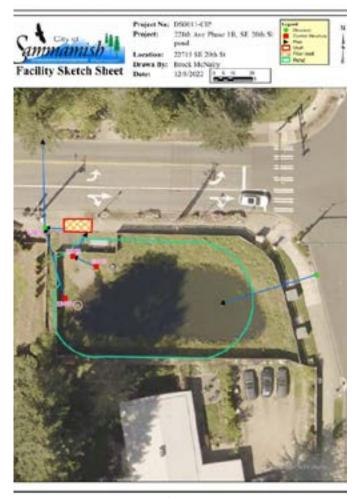
Stormwater Facility #DS0011 in Pine Lake Creek Basin

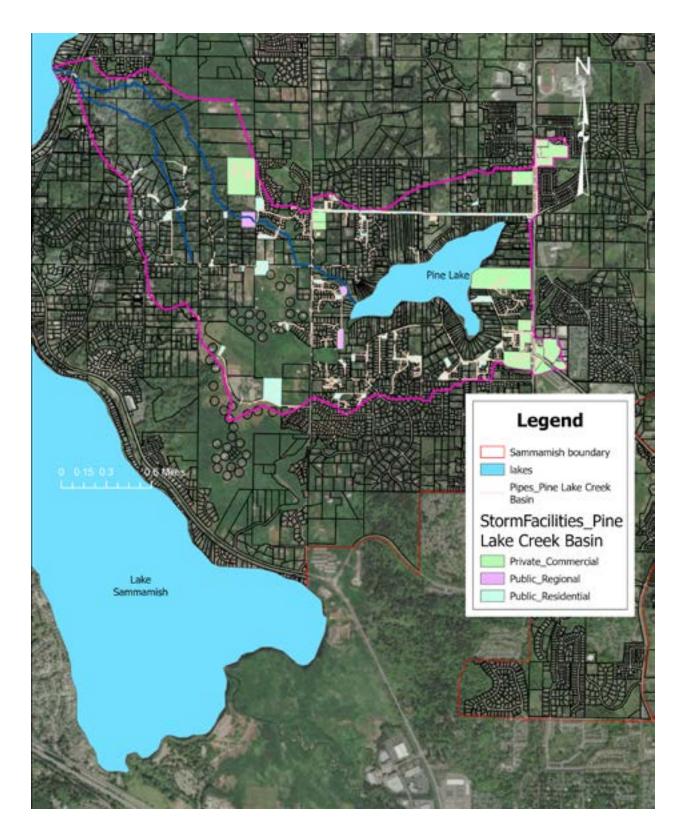
Figure 4-5. Pine Lake Creek Basin Stormwater Facilities

Figure 4-5 shows a map of the stormwater treatment facilities in the Pine Lake Creek basin. The city owns and maintains stormwater facilities that it constructs on public right-of-way or on land acquired for the purpose of providing stormwater treatment. Additionally, the city acquires ownership and maintenance responsibilities for stormwater treatment facilities that are constructed in residential subdivisions after the bonding period has ended and the final development has been approved. Property owners are responsible for maintenance of privately-owned stormwater facilities serving commercial businesses and entities such as churches, schools and water districts. Table 4-1 summarizes the number of facilities by maintenance responsibility (private or public) and general purpose in the Pine Lake Creek basin.

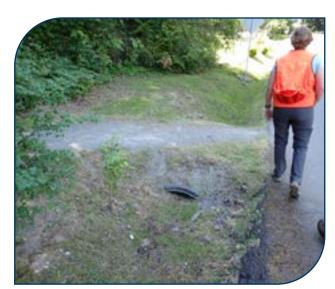
Typical Stormwater Ditch (204th Ave SE)

Existing (and especially older) conveyance systems, similar to existing stormwater treatment facilities, provide an opportunity for improvement for water quality treatment and/or flow control.

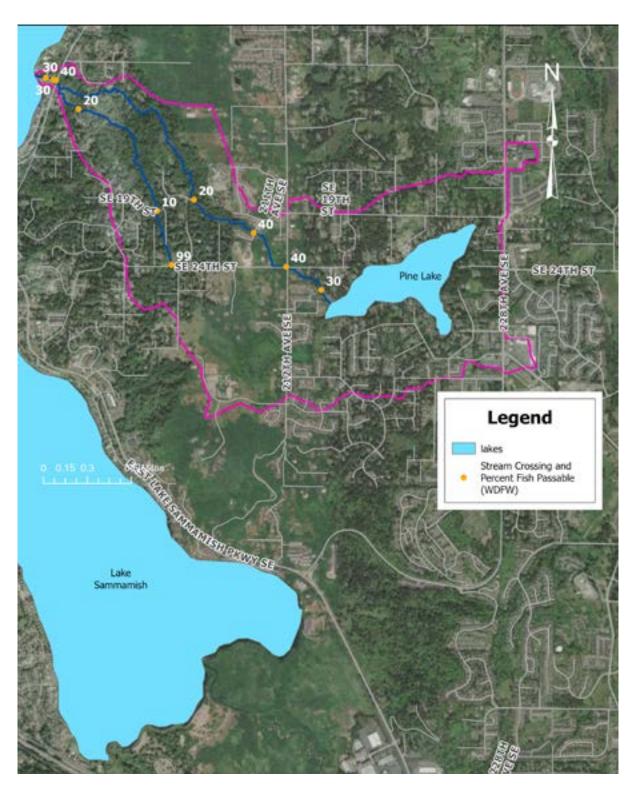
Figure 4-6. Pine Lake Creek Basin Stream Crossings and Estimated Percent Passable for Fish according to WDFW

report, Appendix A. Figure 4-6 shows the stream crossings in Pine Lake Creek Basin and the percent passable according to WDFW's latest evaluations.

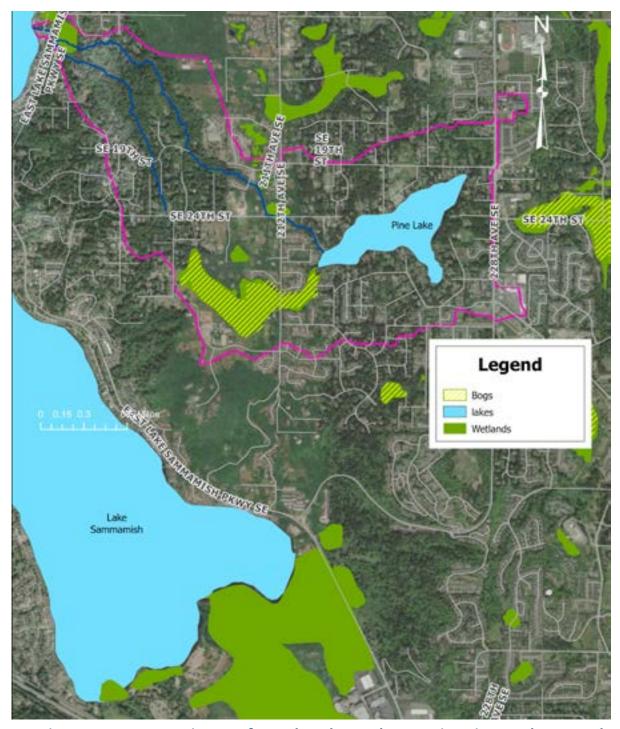
Figure 4-7. Locations of Wetlands and Bogs in Pine Lake Creek Basin and vicinity.

There are several large wetlands in the Pine Lake Creek basin including one sphagnum bog, as shown in Figure 4-7. Water quality data collected for this project indicates the streams have relatively good water quality. Wetlands filter pollutants from urban development, including road runoff, and could be a factor in the results.

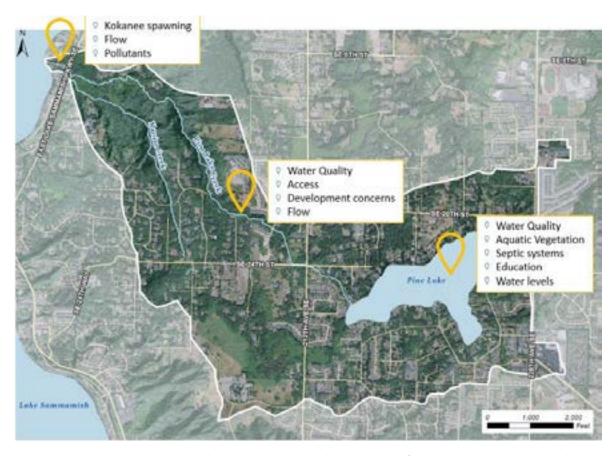
Figure 7-1. General locations and types of issues reported by stakeholders and the community.

Figure 7-1 show the general location and types of issues identified by stakeholders and the public. Figure 7-2 shows the general location and issues that were observed in the field.

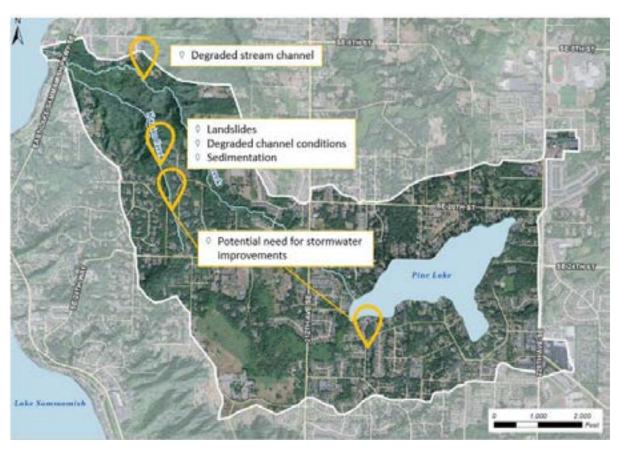
Figure 7-2. General locations and types of issues observed.

where it crosses Kanim Creek, and 212th Avenue SE where it crosses Pine Lake Creek—were reported to have where flat, slow-moving water in wetland-like conditions on both sides of the road, causing the culverts to become submerged during high water. Climate change could result in higher peak flows and storm volumes in the winter months that could result in future flooding (see Hydrology Report, Appendix C).

Data and observations indicate active and historic landslides in upper Kanim Creek, and the channel is deeply incised. Stormwater flows to this section of stream are likely contributing to the observed channel incision. The stormwater facilities

Stormwater flows to Kanim Creek where stormwater facilities are out-dated, may be contributing to erosion observed in the channel. designed to detain flow upstream of the ravine are out-dated and/or may not be functioning as intended. Eroded material from the channel itself and from hillslopes is being temporarily stored in the Kanim Creek floodplain in a flatter section in the ravine. The stream continues to rework this sediment and move the material downstream, although the large wetland complex at the confluence of Pine Lake

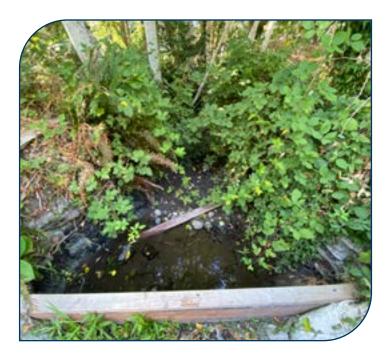
The Pine Lake water level is controlled by the weir at the downstream (northwest) end of the lake. This weir is owned by WDFW, and managed by residents to keep the lake at a level that provides summer recreation opportunities for residents and Pine Lake Park users and releases water at a rate that prevents shoreline flooding in the winter.

Pine Lake weir

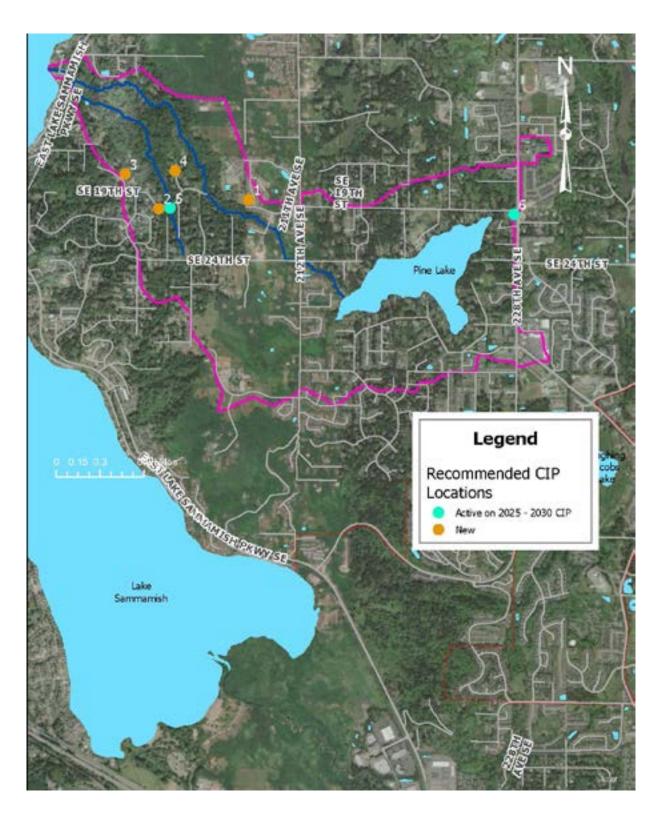
Figure 8-1. Locations of Recommended CIPs.

new elements to existing infrastructure. All four projects will help control flows and improve water quality treatment. The Kanim Creek projects will help reduce erosive

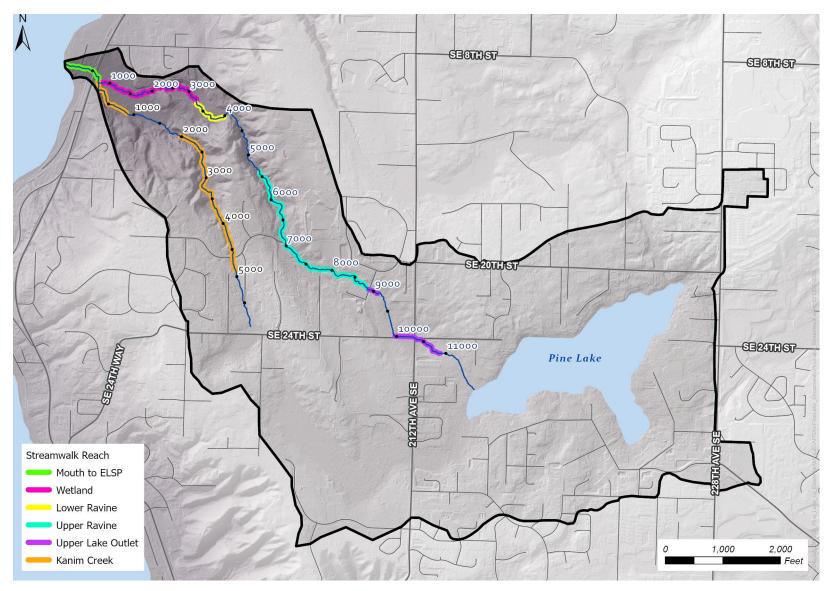
Figure 1 shows the stream alignments with reaches observed during the stream assessments highlighted. The streamlines shown in the map (and throughout this document) were updated from King County hydrography based on field observations on upper Kanim Creek, and recent LiDAR (Light Detection and Ranging) topography on lower Pine Lake and Kanim creeks and the confluence area. Figure 2 presents longitudinal profiles of both creeks extracted from the recent LiDAR and updated streamlines.

Figure 1. Stream assessment reaches. Stationing indicates distance along the stream channel from a) Lake Sammamish on Pine Lake Creek and b) Pine Lake Creek confluence on Kanim Creek.

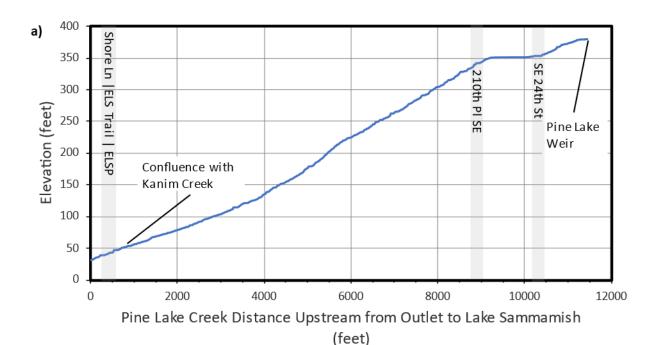
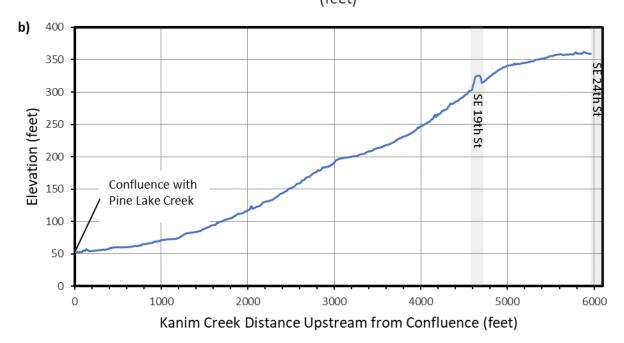
Figure 2. Stream profile plots for Pine Lake and Kanim creeks. a) Pine Lake Creek from Lake Sammamish to Pine Lake weir and b) Kanim Creek from Pine Lake Creek to headwaters. Road crossings are indicated by shaded bars. Note that the distance scale (x-axis) is different for the two plots.

The lack of road crossings is notable on the profiles for both creeks. Unlike many urban and suburban streams in western Washington, the Pine Lake Creek system (downstream of Pine Lake) has had limited direct connection with development. This is largely due to the topography

The following sections describe observations of Pine Lake and Kanim creeks, presented in the downstream direction to better reflect the hydraulic and geomorphic interrelation between sections. Each stream reach is divided into sub-reaches defined by dominant processes and characteristics. Pine Lake Creek and Kanim Creek stream stationing (STA) referred to in the text below is referenced from Lake Sammamish for Pine Lake Creek and from the Pine Lake Creek confluence for Kanim Creek (see Figure 2a. and 2b).

During the September 22 streamwalk, the channel in the upper ravine was dry, though isolated wetted pools were observed. The upper ravine has a relatively uniform average slope of 4% (Figure 2a) below STA 7500. Between 210<sup>th</sup> Place SE and STA 7500, the channel has step-pool characteristics, with wood and large boulders forming channel steps (Photo 7). In addition to isolated wetted pools, water was observed in the channel between STA 7100 and STA 7300, likely from groundwater input at the interface of advanced outwash sand and underlying fine deposits (Photo 8). On the right bank near STA 7500, a narrow (about 1- to 2-foot wide), incised

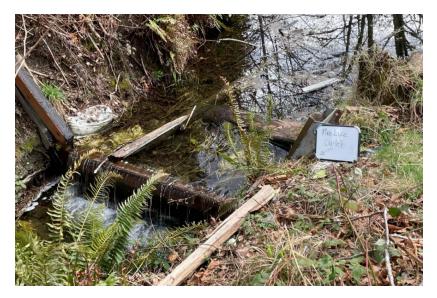
The Pine Lake outlet weir is approximately 7.5 feet wide (Photo 1). Downstream, the channel narrows to 4.5 feet wide and is incised approximately 5 to 6 feet. The channel in this location is a straight, ditch-like feature that is mostly comprised of silt with occasional gravel and cobbles. The water depth in March 2023 was approximately 0.5 feet downstream of the weir. The weir is classified as a fish passage barrier by the Washington Department of Fish and Wildlife in their Dam Assessment Report dated 11/6/2012.

Photo 1. Pine Lake outlet weir looking upstream, STA 10900 (March 2023).

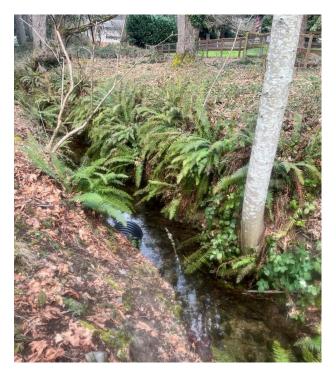
Photo 2. Pine Lake Creek immediately downstream of weir, looking downstream at bypass outfall (March 2023).

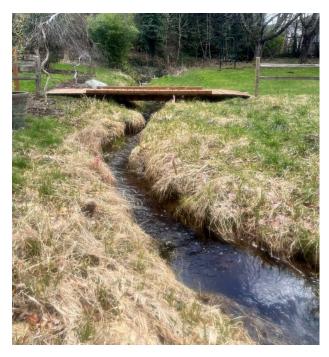
At the southeast corner of the intersection of SE 24<sup>th</sup> Street and 212<sup>th</sup> Avenue SE, Pine Lake Creek and surrounding wetlands were modified in a mitigation project that restored some natural characteristics to the stream corridor by introducing native plants, floodplain connection, and meanders to the channel. This portion of the channel may be the only non-ditch-like section

Photo 3. Mitigation site at the SE corner of SE 24th St and 212th Ave SE, looking upstream STA 10200 (March 2023).

between the weir and 210<sup>th</sup> Avenue SE. Our visit indicated that maintenance is needed on the mitigation site to control invasive plants, such as reed canary grass. Photos 3 and 4 show the stream and wetland before it re-enters roadside ditches along SE 24<sup>th</sup> Street and 212<sup>th</sup> Avenue SE. Photo 5 shows the channel in the ditch adjacent to SE 24<sup>th</sup> Street.

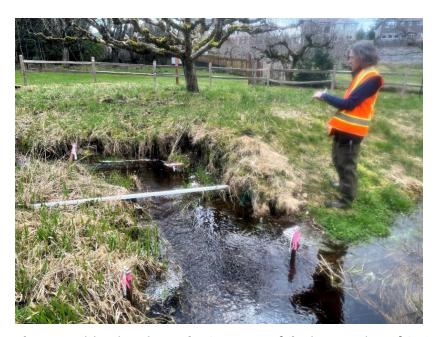
Photo 4. Mitigation site at the SE corner of the intersection of SE 24th Street and 212th Ave SE, where channel becomes braided through wetland, STA 10100 (March 2023).

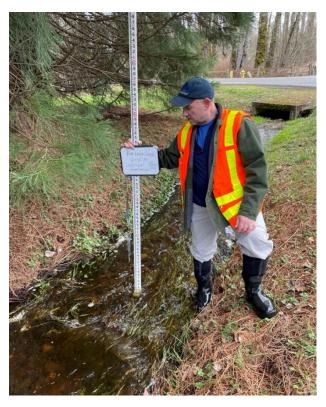
Photo 5. Pine Lake Creek in roadside ditch on south side of SE 24th Street, downstream of mitigation site. Looking downstream, STA 10000 (March 2023).

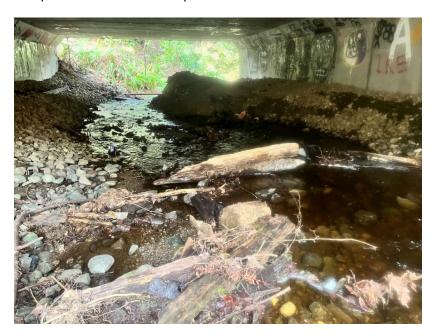
Photo 6. Looking downstream under 210th Place SE bridge, STA 8450 (March 2023). Notice the mound of sediment next to right wall at the downstream end of the bridge.

The upper ravine sub-reach begins at the 210<sup>th</sup> Place SE crossing near STA 8900 and extends downstream to approximately STA 4000<sup>1</sup>. A bridge crosses 210<sup>th</sup> Place SE over Pine Lake Creek at the upper end of the ravine sub-reach (Photo 6). Our observations suggested that material at the downstream end of the bridge is not a depositional feature and may be a relic channel bank from prior to bridge construction (see Photo 6). From this location downstream, the stream steepens and enters a deep ravine.

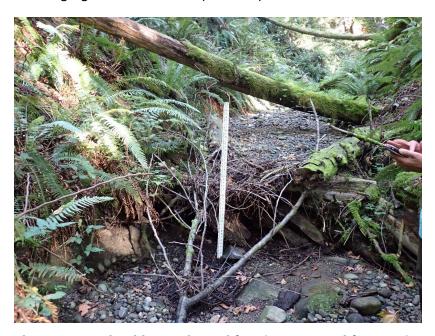
Photo 7. Large boulders and wood forming step pool features in steeper reach of Pine Lake Creek at STA 7500, downstream of 210<sup>th</sup> Place SE (September 2023), looking upstream direction.

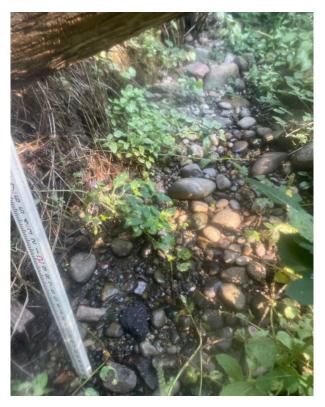
Photo 8. Water in channel observed between STA 7100 and STA 7300 (September 2023).

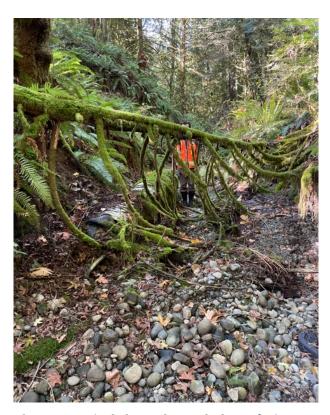
Photo 9. Typical channel morphology, facing upstream. Fallen trees span valley walls and provide limited hydraulic function. STA 7000 (September 2023).

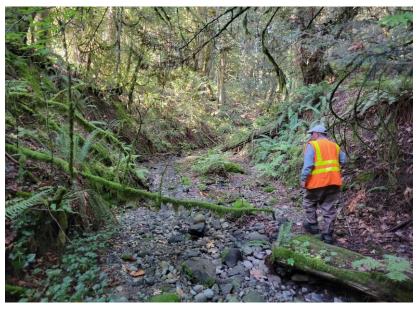
Through the upper ravine, Pine Lake Creek is deeply incised 10 to 15 feet into the adjacent hilly terrain, forming an over-widened U-shaped stream corridor (Photos 9 and 10). Downstream of STA 7500, channel bottom width ranges from 5 to 12 feet with a plane-bed morphology. The bed composition is poorly sorted cobble, small boulders, and gravel materials. Overall, ravine banks appear relatively stable, anchored by vegetation. However, vertical faces composed of varying assemblages of till and outwash materials were also observed. A single slump was observed along the right bank near STA 5800 (Photo 11).

Photo 10. Upper ravine channel and corridor, facing downstream, near STA 6400 (September 2023).

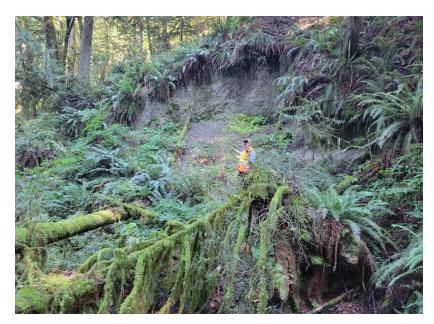
Photo 11. Slump on right bank of upper ravine channel, near STA 5800 (September 2023).

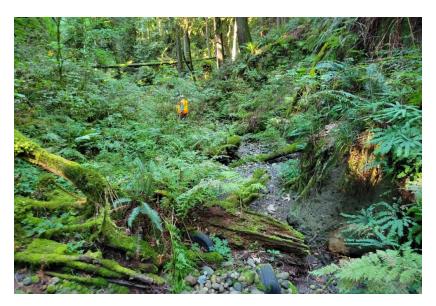
Photo 12. Large woody material (LWM in upper ravine facing downstream, near STA 5700. Note narrower low flow channel, remnant tire grade control (bottom center), and vertical bank composed of cemented till (bottom, right) (September 2023).

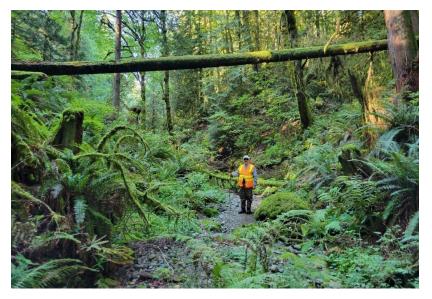
Photo 13. Example of treefall not interacting with stream channel. Looking downstream direction, near STA 5600 (September 2023).

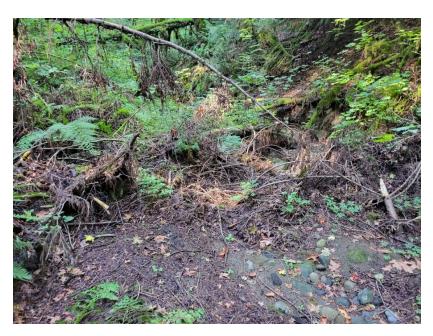
Photo 14. LWM debris jam, facing downstream, near STA 5500 Note, upstream sediment build-up (in foreground) (September 2023).

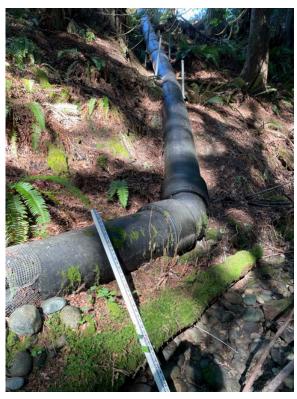
Several stormwater outfalls discharge to the upper ravine reach. Photos 15 and 16 show outfalls from stormwater ponds that serve The Crossings at Pine Lake development. Both outfalls appeared to be in good conditions without any signs of stream bank or bed erosion in the vicinity of the discharge points. A 12-inch corrugated metal pipe discharges from Pond D91443 on the left bank of the channel near STA 7050 (Photo 17). One private driveway road crossing (SE 19<sup>th</sup> St) spans the middle of the upper ravine reach at STA 6950. This crossing consists of a 7-to 8-foot-wide corrugated metal pipe (CMP) arch structure. Near-vertically placed logs, two to three feet high, provide grade control at the outlet of the culvert, behind which fine gravels are deposited forming a plane bed (Photo 18). According to the WDFW Level A Culvert Assessment report completed 10/31/2012, this culvert is a partial barrier and was rated 33% passable. The reason for the partial barrier rating was because of the water surface drop at the outlet of the culvert.

Photo 16. Right bank stormwater discharge pipe from Pond D92928, STA 7800 (September 2023).

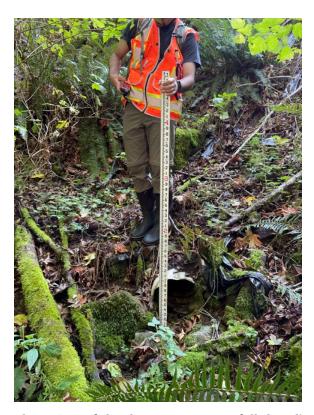
Photo 17. Left bank stormwater outfall that discharges from Stormwater Pond D91443 near STA 7050 (September 2023).

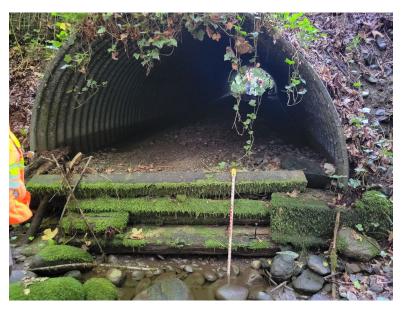
Photo 18. SE 19th Street private driveway culvert at STA 6950, looking upstream (September 2023).

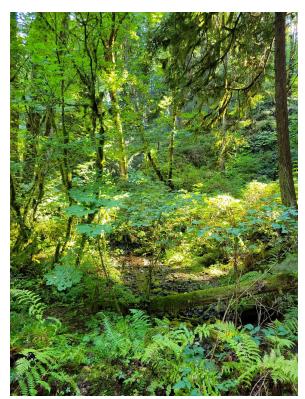
Photo 19. Pine Lake Creek channel corridor, facing upstream, near STA 4000. Note, steeper terrain of upper ravine sub-reach in the background (September 2023).

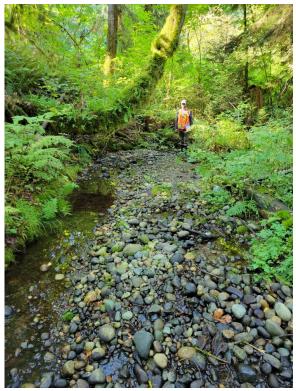
Photo 20. Plane-bed channel, with small pool, in the lower ravine sub-reach, facing downstream near STA 3600 (September 2023).

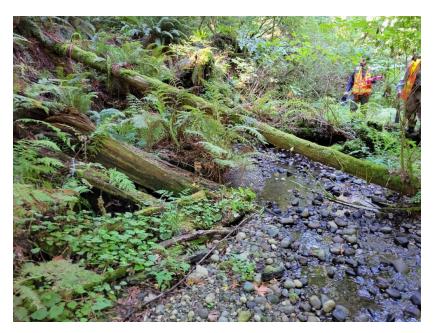
Photo 21. LWM in the lower ravine sub-reach, facing downstream near STA 3400 (September 2023).

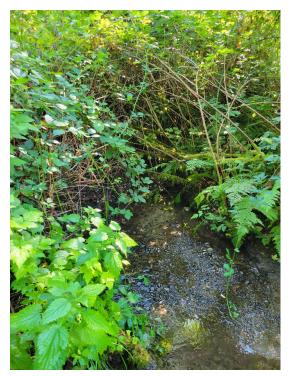
Photo 22. Channel in the upper wetland reach, facing upstream, near STA 2800 (September 2023).

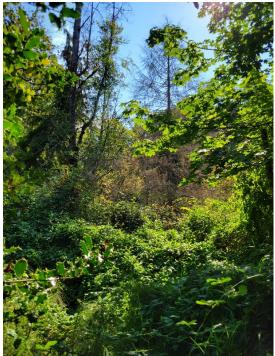
Photo 23. Canopy in the upper wetland reach, facing upstream, near STA 2900 (September 2023). Note dead fir tree standing in the center.

The dead trees suggest that this sub-reach is subject to frequent flooding. Photos taken upstream and downstream indicate abrupt fining of the streambed composition. What specifically initiated these conditions is uncertain, especially since the reach-averaged slope remains relatively steep (according to LiDAR). Localized backwater conditions originating downstream may cause flow to slow down, resulting in excess sediment deposition, flooding, and tree die-off. In turn, a positive-feedback loop could be initiated as a thick understory is allowed to grow, choke the channel, and result in more deposition. Alternatively, there could be unobserved manmade features in this sub-reach that are causing these conditions.

assessment of this sub-reach by a wetland scientist could help further define the quality and

function of the upper wetland.

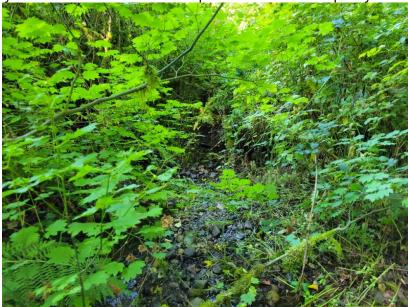
Photo 24. Upstream limit of the upper wetland reach, facing downstream, near STA 3300 (September 2023).

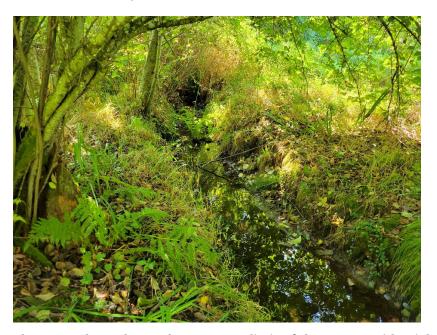
Photo 25. Channel near the upstream limit of the upper residential reach, facing upstream, near STA 2800 (September 2023).

generally low. The channel gradually becomes more incised in the downstream direction, with bank height on the order of two feet near the upstream end (Photo 25) and deepening to 3 to 5 feet downstream (Photo 26). A small low-lying wood pedestrian bridge spans the channel near STA 2650 (Photo 27). Bed material composition in this reach generally coarsens in the downstream direction, from sand to small gravels upstream, to gravel to small cobbles downstream. No evidence of fixed grade control, either natural LWM or manmade structures, were observed. Some active bank erosion was observed on the outside of a bend near STA 2500 and bank slumping near STA 2260 (Photo 26).

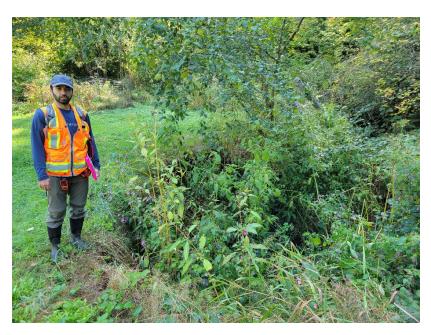
Photo 26. Thickly vegetated and incised channel (right) near the downstream limit of the upper residential reach, facing upstream, near STA 2260. Note, NHC personnel standing adjacent to scarp at slumped bank (September 2023).

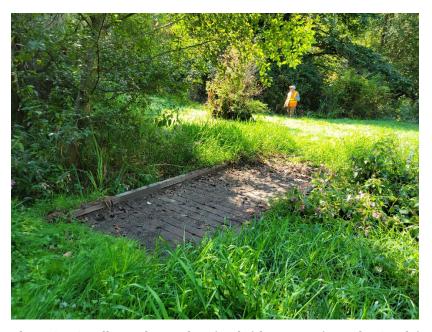
Photo 27. Small wooden pedestrian bridge over Pine Lake Creek in the upper residential reach, near STA 2650 (September 2023).

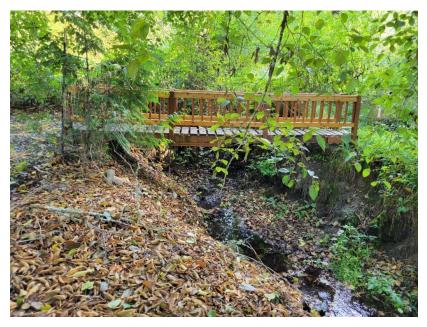
Photo 28. Small wooden pedestrian bridge over Pine Lake Creek in the lower residential reach, facing upstream, near STA 2260. Note channel incision and lack of vegetation (September 2023).

It is unclear if this lack of vegetation is due to landowner maintenance, a more mature canopy cover, erosive flows, or possibly all three. The channel corridor widens from approximately 10 to 25 feet in the downstream direction. Point bars were observed on the inside of meander bends. Actively eroding vertical banks were observed along much of the lower segment of the residential reach (Photo 29). In some locations, it was apparent that landowners were trying to stabilize banks with placement of small woody debris, wood or steel stakes, and erosion control fabrics (Photo 30). The channel generally maintains a pool-riffle morphology and is composed of coarse gravels and cobble-sized materials. The sub-reach is generally free of LWM. Three small pedestrian bridges cross the creek in this sub-reach reach (Photo 28).

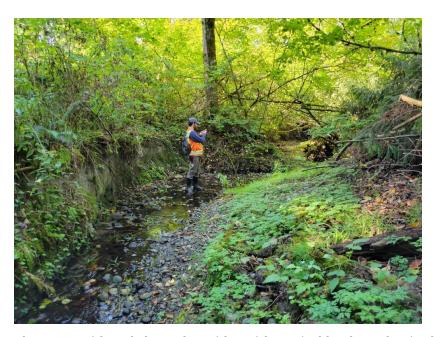
Photo 29. Widened channel corridor with vertical banks and point bar formation in the lower residential reach, facing downstream, near STA 2150 (September 2023).

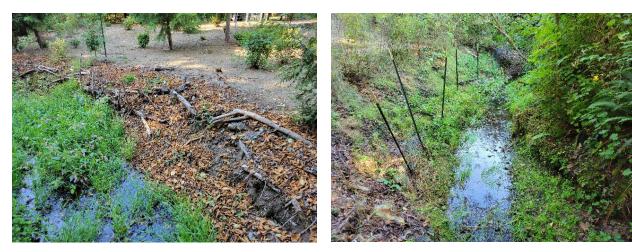
Photo 30. Bank erosion control measures placed by landowners in the lower residential reach (September 2023).

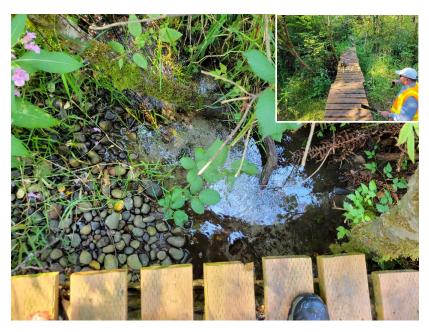
Photo 31. Bed material composition at a small wood pedestrian bridge crossing the assumed mainstem of Pine Lake Creek in the lower wetland sub-reach near STA 1500, and view of the bridge (inset) facing south (September 2023).

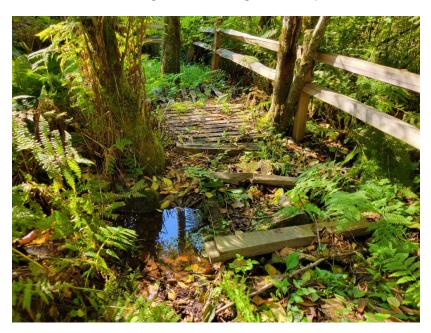
Photo 32. Channel braid crossing landowner constructed boardwalk, in the lower wetland subreach approximately 100 feet west of STA 1500 (September 2023).

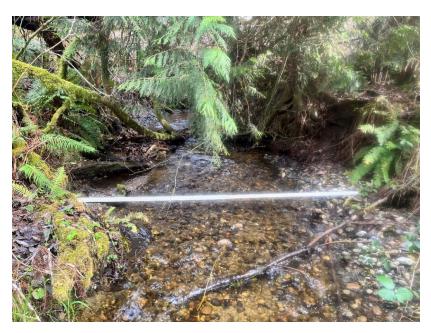
Photo 33. Pine Lake Creek near STA 900, looking upstream (March 2023).

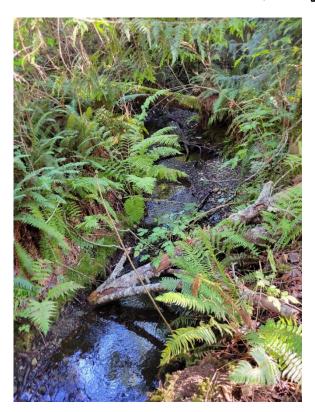
Photo 34. Moderately incised channel in the lower wetland sub-reach, facing upstream, near STA 1200 (September 2023).

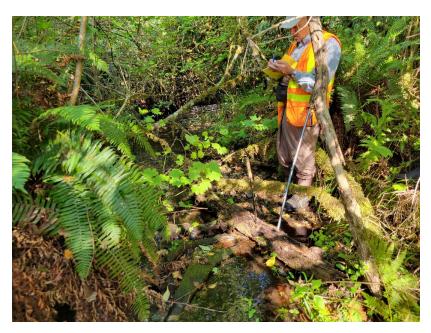
Photo 35. LWM observed in the lower wetland sub-reach near STA 1300 (September 2023).

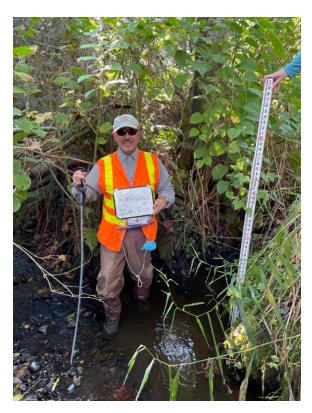
Photo 36. Confluence of Pine Lake Creek and Kanim Creek, near STA 800 (September 2023).

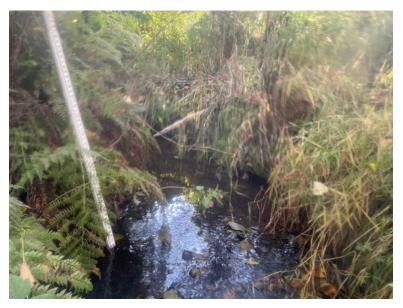
The downstream-most reach of Pine Lake Creek extends about 800 feet from the confluence with Kanim Creek (Photo 36) to the mouth at Lake Sammamish. The stream channel is incised immediately upstream of East Lake Sammamish Parkway, and bank erosion was observed on the right bank (Photo 37).

Photo 37. Incised channel upstream of East Lake Sammamish Parkway, looking upstream, near STA 700 (September 2023).

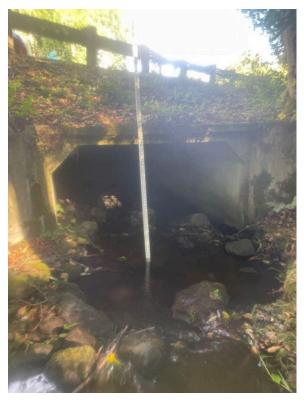
Photo 38. East Lake Sammamish Culvert, looking downstream, STA 600 (September 2023).

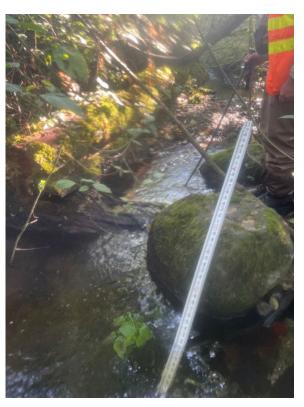
Photo 39. Boulders in channel between East Lake Sammamish Trail and East Lake Sammamish Parkway (September 2023).

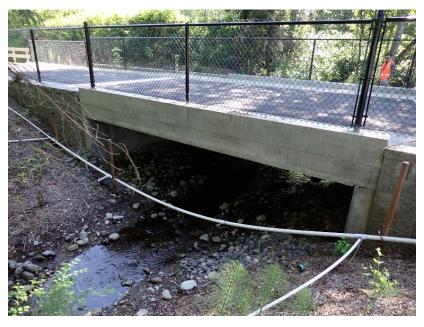
Photo 40. East Lake Sammamish Trail culvert, looking north (September 2023).

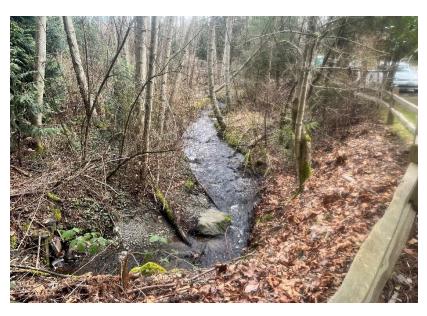
Photo 41. Section between Shore Lane and East Lake Sammamish Trail, looking upstream (March 2023).

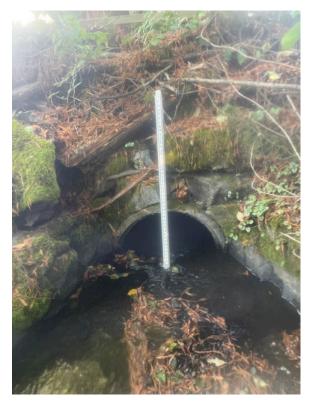
Photo 42. Shore Lane culvert (September 2023). Looking upstream.

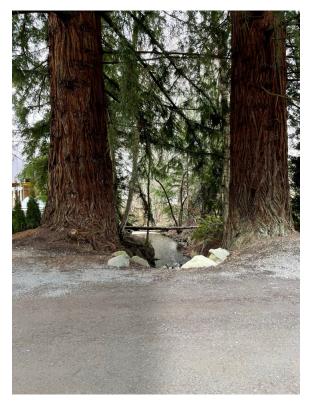
Photo 43. Shore Lane crossing looking downstream between two redwood trees (September 2023).

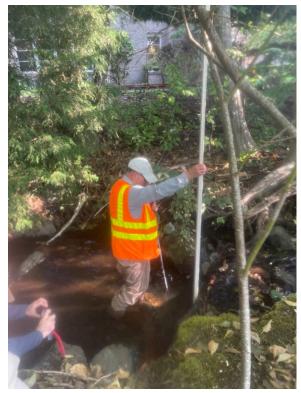
Photo 44. Downstream of Shore Lane, pool downstream of wood sill, near STA 200 (September 2023).

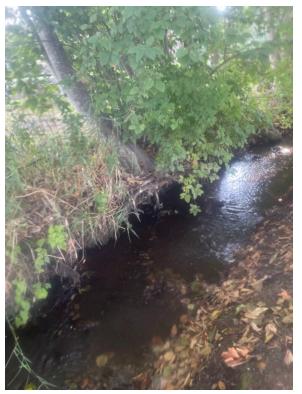
Photo 45. Pine Lake Creek immediately upstream of mouth, STA 100 (September 2023).

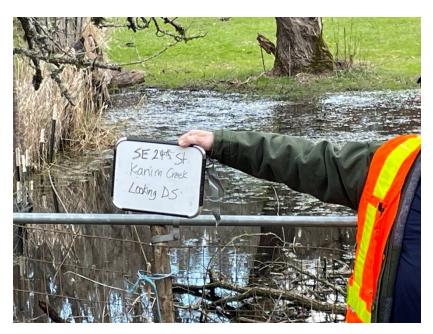
Photo 46. Kanim Creek headwaters at SE 24th Street, STA 5100 (March 2023).

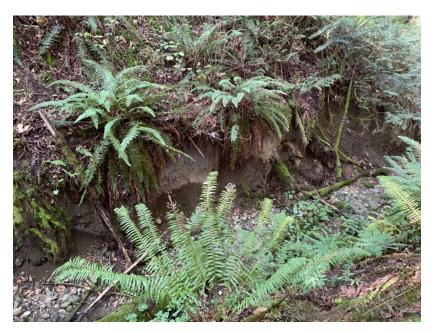
Kanim Creek is deeply incised downstream of the SE 19<sup>th</sup> street crossing (up to 6 or 7 feet). It remains incised until approximately STA 2500, where the channel flattens out and significant aggradation has occurred. Photo 47 shows an example of channel incision observed in Kanim Creek. Photo 48 shows an active left bank hillslope failure near a stormwater outfall. Photo 49 shows deposition in a December 2019 photo. The stream channel is not confined to a single thread in this area and is braided across the deposition zone until it re-forms a single thread incised into the thick sediment downstream at approximately STA 2200 (Photo 50).

Photo 47. Channel incision in Kanim Creek near STA 3200 (September 2023).

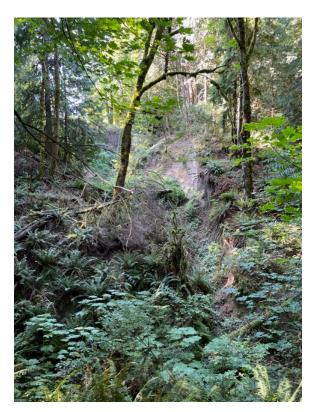
Photo 48. Hillslope failure near stormwater outfall on left bank near STA 3100 (September 2023).

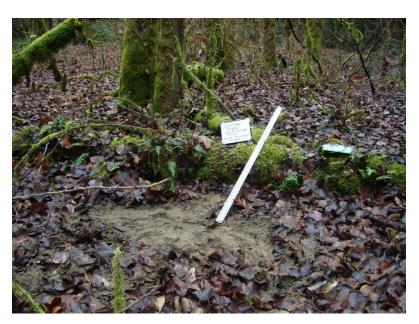
Photo 49. Deposition of sand observed near STA 2200 (December 2019).

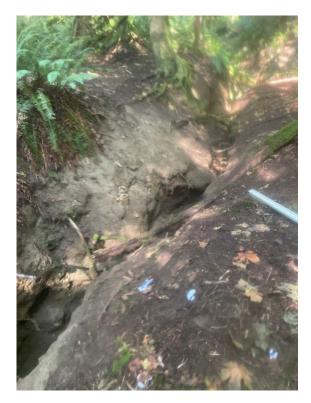
Photo 50. Deep incision into deposited sediment on downstream end of deposition zone, near STA 2750 (September 2023).

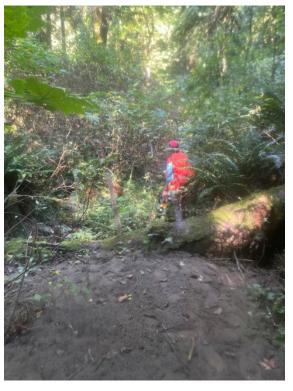
At the time of our September 2023 visit, there was no standing water in the channel upstream of STA 1500, however, some wet zones were observed where seepage was occurring on the banks. Photo 51 shows fine sand deposited behind a log sill near STA 1500. Water was observed in the channel around STA 1500 and the channel started to have wetland-like characteristics. Kanim Creek was not walked between STA 1500 and STA 1000 due to difficult terrain and accessibility.

Photo 51. Fine sand deposited behind log sill near STA 1500 (September 2023).

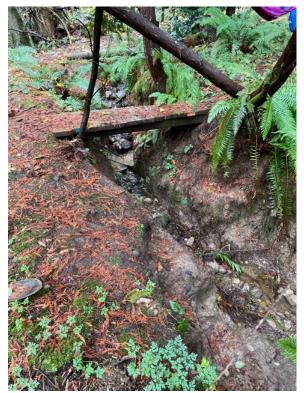
A stormwater facility on the north side of SE 19<sup>th</sup> Street discharges to the roadside ditch on SE 19<sup>th</sup> before entering Kanim Creek. Photo 52 shows the incised channel that has formed downstream of the stormwater outfall. This erosion has the potential to worsen and contribute to water quality issues in Kanim Creek.

Photo 52. Channel formed downstream of stormwater outfall from Stormwater Facility D92924.

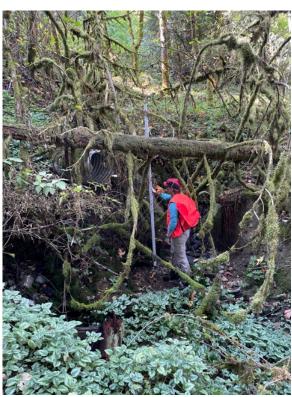
Downstream of SE 19th Street, the creek flows through a deep ravine, with active landslides, erosion, and deposition. Three culverts (two conveying Kanim Creek, and one conveying stormwater) are located at the head of the ravine and are perched several feet above the channel floor. Photo 53 shows the culverts.

Photo 53. Perched culverts conveying Kanim Creek at SE 19th Street, STA 3800 (September 2023).

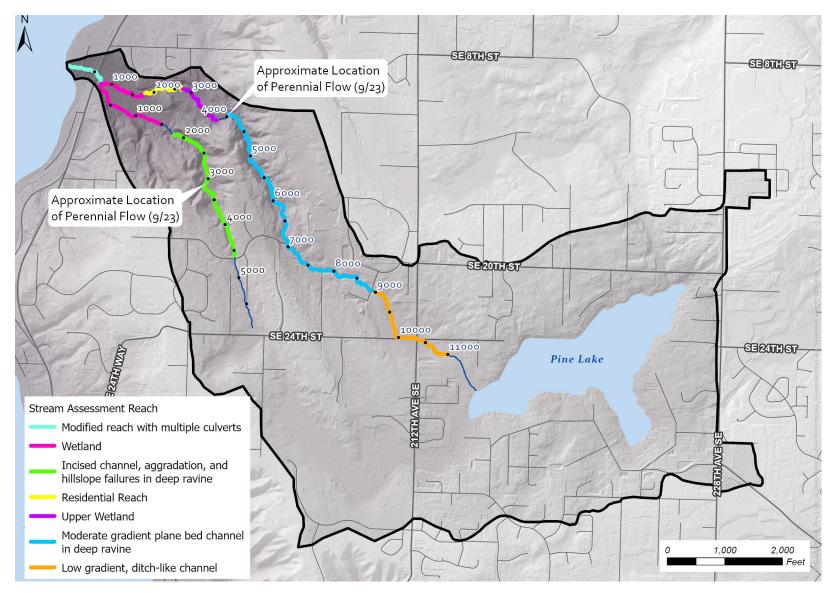
Figure 3. Sub-reach characteristics summary

Reach	Characteristics	Potential Actions
	Kokanee salmon redds have been observed in this sub-reach.	Coordinate with stream-side landowners for restoration and enhancement opportunities.
Pine Lake Creek Lower Wetland	Provides sediment storage that minimizes potential downstream impacts to City and private property owners.	Coordinate with property owners for restoration and enhancement opportunities.
Kanim Creek Upper Ravine	Extreme channel incision and unstable slopes with subsequent deposition.	Flow control in upland areas.
Kanim Creek Lower Wetland	Provides sediment storage that minimizes potential downstream impacts to City and private property owners.	No actions recommended.
Lower Pine Lake Creek	Engineered channel structures create step-pool features. Multiple culverts that are not full barriers to fish passage.	Coordinate with property owners for restoration and enhancement opportunities and culvert improvements when opportunities arise.

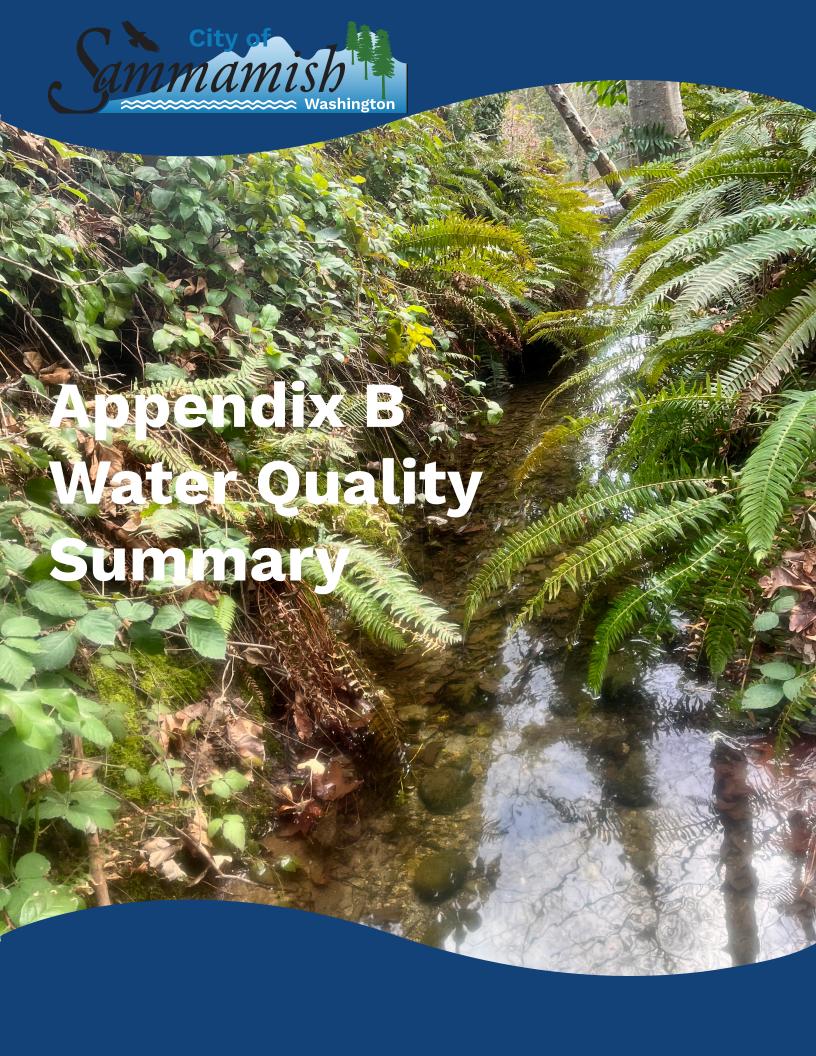
Pine Lake and Kanim creeks display distinct geomorphic characteristics in the assessed reaches that influence fish habitat and viability. Table 1 summarizes the general characteristics, conclusions, and recommendations for potential actions to improve quality and function for each reach. Specific project and program recommendations are addressed in the body of the Basin Plan document. Figure 3 summarizes the general character of each reach.

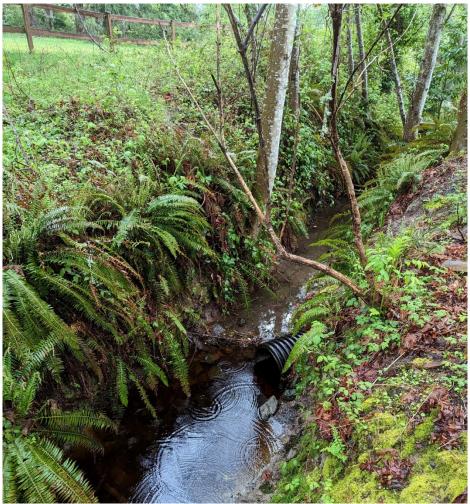
is via a path through the stormwater facility; and flow and water quality measurements were taken upstream of the stormwater outfall (Photograph 1). Under low flow conditions the exact position of the flow measurement varied depending on channel conditions, but the water quality samples and measurements were always collected upstream of the stormwater outfall.

Photograph 1. PLC Upper sample location between pipe and weir.

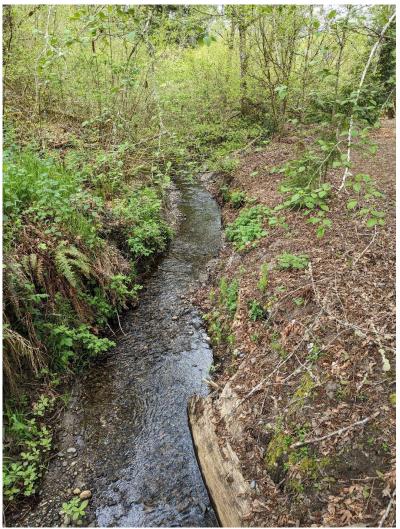
PLC Lower is located in Pine Lake Creek upstream of the confluence with Kanim Creek. This site was intended to measure the flow and water quality in Pine Lake Creek before it joins with Kanim Creek and provide a point of comparison with PLC Upper. This site is on private property and access was granted by the property owner. The sample location was just downstream of the bridge near the eastern edge of the property (Photograph 2). The reach just downstream of the bridge is relatively straight and provided the best conditions for flow and water quality measurements.

Photograph 2. PLC Lower sample location looking downstream from bridge.
