# **Purpose and Background**

Zackuse Basin Plan was completed in 2019 and Laughing Jacobs was completed in 2022. This plan, the Pine Lake Creek Basin Plan, is the fifth and one of the last large basins with a primary creek system in the city to be evaluated. The remaining basins to be updated include Beaver Lake (not included in Laughing Jacobs Basin Plan), and the Monohon and Panhandle basins, which both include multiple small tributaries that flow directly to Lake Sammamish from

#### **Pine Lake Creek Basin Overview**

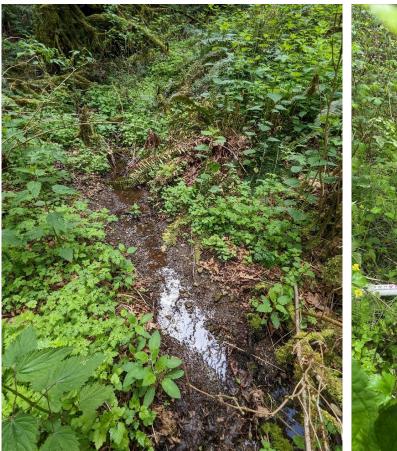
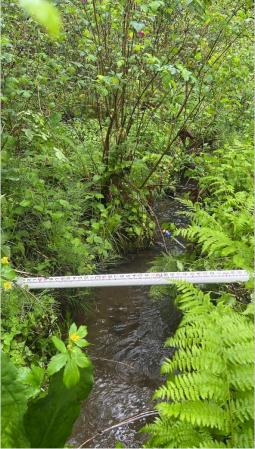
Kanim Upper is located in the upper region of the Kanim Creek basin. This sampling site (Photograph 3) represents the headwaters of Kanim Creek and is accessed from SE 19th Street just west of 202nd Pl SE via a faint trail on the right bank on the upstream side. Water quality and flow measurements were intended to be collected if stream conditions allowed, but due to the stream being too shallow or dry during this study, no samples were collected from this site.

Photograph 3. Kanim Upper channel upstream of SE 19th Street.

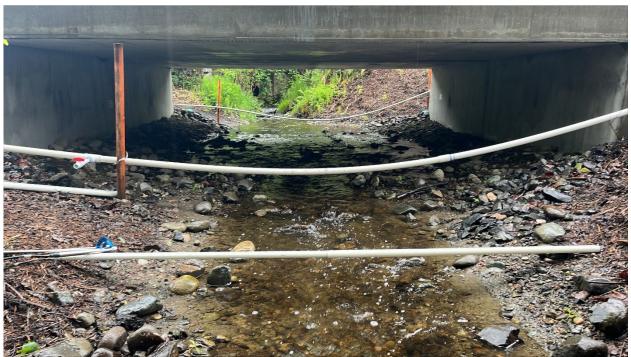
Photograph 5. PLC Outlet sample location looking upstream.

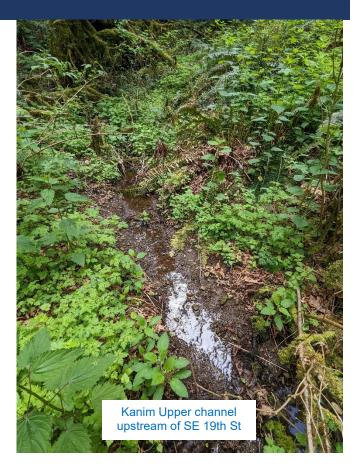
# **Kanim Upper**

Kanim Upper is located in the upper region of the Kanim Creek basin. This site is intended to represent the headwaters of Kanim Creek. Access Kanim Upper by parking on shoulder of SE 19th St just west of 202nd Pl SE. There is a faint trail on the right bank on the upstream side that provides access to the creek. Water quality and flow measurements can be collected if stream conditions allow but under most conditions Kanim Creek will be too shallow to collect water quality or flow measurements from. Field staff should observe whether the creek has visible flow or is dry.

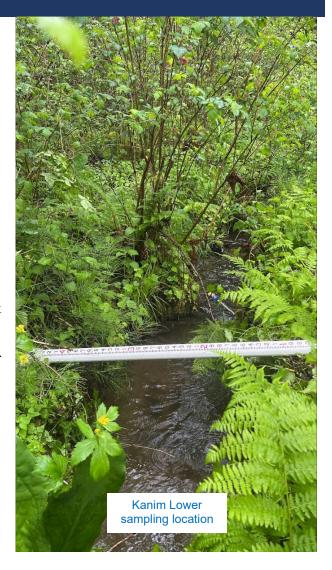
### **Kanim Lower**

Kanim Lower is in Kanim Creek just upstream of the confluence with Pine Lake Creek. This site is intended to measure the flow and water quality from Kanim Creek and represent the overall contributions of Kanim Creek within the Pine Lake Creek Basin. We have been given permission to access Kanim Creek near the pond on the northwest corner of the property. Email the homeowner at least one day in advance so they can leave the gate open.

Park near the shed making sure to leave the driveway clear for access to the house and walk down the grassy hill toward the pond. The best reach for flow and water quality measurements is behind a clump of rhododendrons just east of the pond.

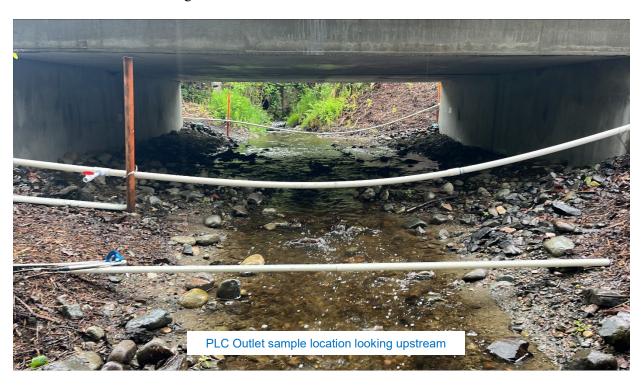
# **PLC Outlet**

PLC Outlet is in Pine Lake Creek below the confluence of Pine Lake Creek and Kanim Creek. This site is intended to measure the flow and water quality conditions of the entire basin just upstream of where the creek flows into Lake Sammamish. Access is just downstream of East Lake Sammamish Trail from East Lake Sammamish Shore Lane SE. Use care to ensure you stay off of private property near the site. The best reach for flow and water quality measurements is just downstream of the trail bridge.

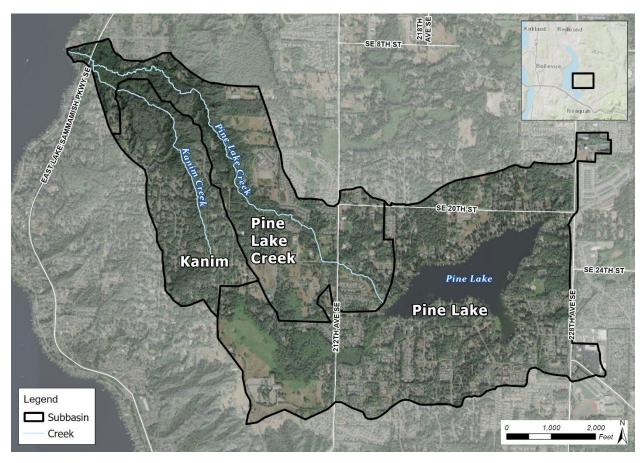
Figure 1.1 Project area main subbasins

Figure 1.1 shows the project area highlighting the main subbasins and creeks.

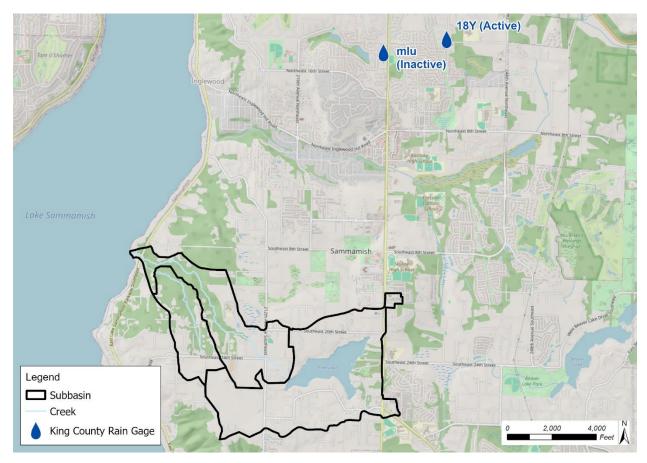
Figure 2.1 Rain gages used in the model development.

Meteorological datasets were developed in previous work by NHC, primarily for King County. NHC obtained the precipitation data from 1992 to 2022 in 15-minute intervals from the Mystic Lake station<sup>1</sup> through the King County Hydrologic Information Center<sup>2</sup>, as shown in Figure 2.1. These records were extended back in time through water year 1949, based on rainfall patterns recorded at the long-term National Weather Service gage at SeaTac airport. A scaling factor of 1.167 was applied to translate the long-term data to the gage location to represent differences in annual precipitation volumes.

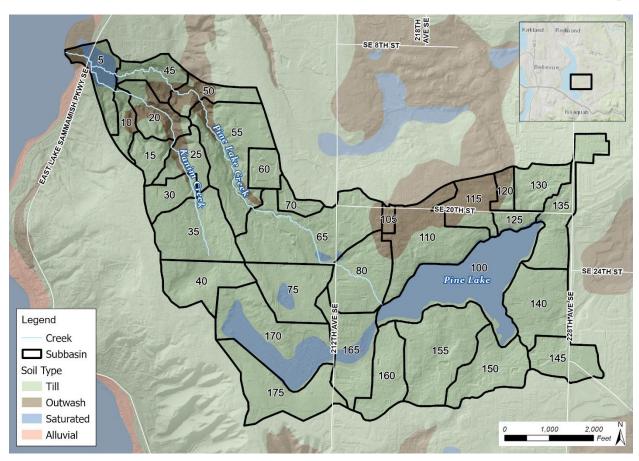
Figure 2.2 Subbasins delineation and soil types used in the HSPF model.

NHC divided the watershed's three main subbasins into 32 smaller subbasins. The subbasin delineation primarily relied on a topographic map created from King County 2016 LiDAR data (Quantum Spatial, 2017) and drainage utilities maps. In areas where uncertainties were higher, NHC verified or adjusted the boundaries through communication with the City and/or field observations. Figure 2.2 shows the delineated subbasins with the corresponding number of each subbasin, where Subbasin 5 is the most downstream subbasin, in which the mouth of Pine Lake Creek is located. It should be noted that initially, from available watercourse mapping, the confluence of Pine Lake Creek and Kanim Creek was identified at the downstream end of Subbasin 10, but LiDAR analysis following the subbasin delineation and model development showed that the actual confluence is located further downstream in Subbasin 5. The boundaries of Subbasins 5 and 10 were not further adjusted because the differences in upstream drainage areas to the confluence are small and the impact on flows would be well within model uncertainties.

NHC categorized surface geologic units<sup>4</sup> into several broad soil types that are linked to distinct runoff response characteristics: till, outwash, saturated, and alluvial, as shown in Figure 2.2. Only an insignificant portion of Subbasin 5 was classified as an alluvial type, so this was mapped to outwash to simplify the modeling process. Water bodies were assigned a saturated soil type.

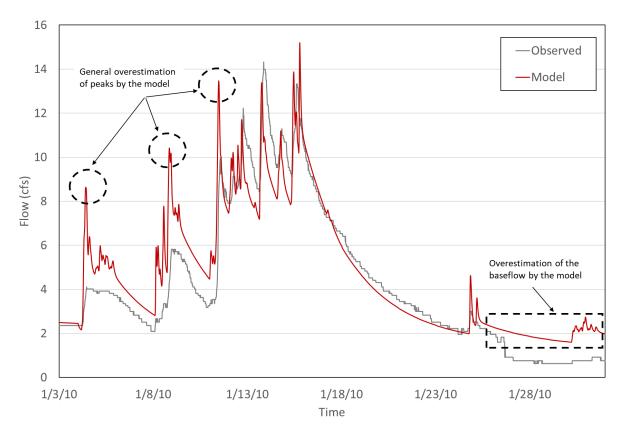
Figure 3.1 Comparison of the calibrated model and the observed flows for a specific event.

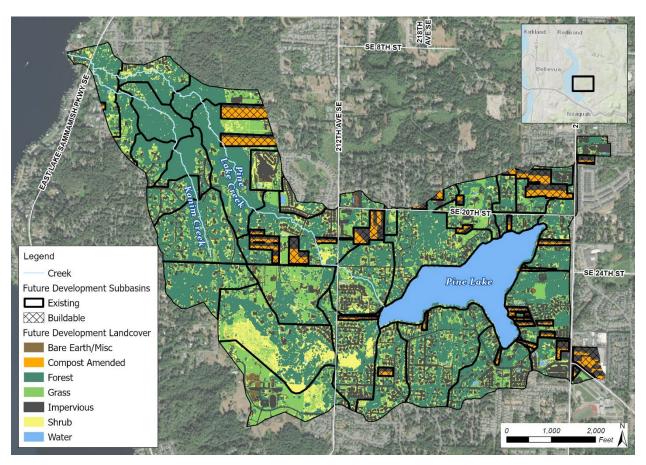
representative of a pasture land cover type. Figure 4.1 shows the buildable areas and new land cover assignments for the future development scenario. A hypothetical flow control facility for the developing portion of each subbasin was sized to meet existing flow control standards using methods of the Western Washington Hydrology Model (WWHM), including infiltration for areas with outwash soils.

Figure 4.1 Future development scenario subbasins and land cover

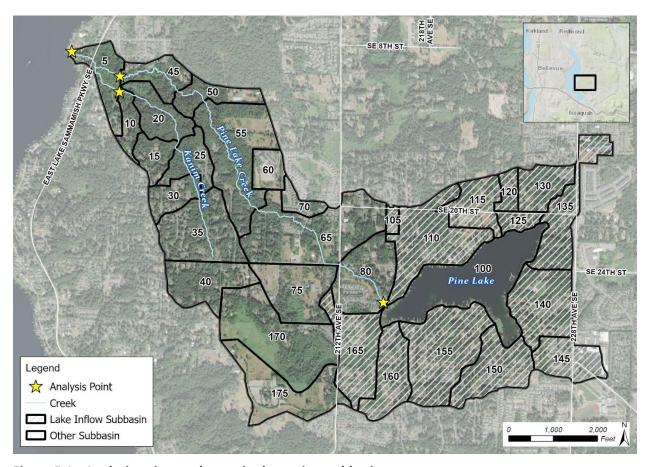
Figure 5.1 Analysis points and areas in the project subbasins

Five key locations (shown in Figure 5.1) were selected to output flow: Pine Lake Creek mouth, Pine Lake Creek at confluence with Kanim Creek, Kanim Creek mouth, Pine Lake outflow, and total inflow to Pine Lake, which is the summation of flows from subbasins adjacent to the lake (hatched subbasins in the figure).

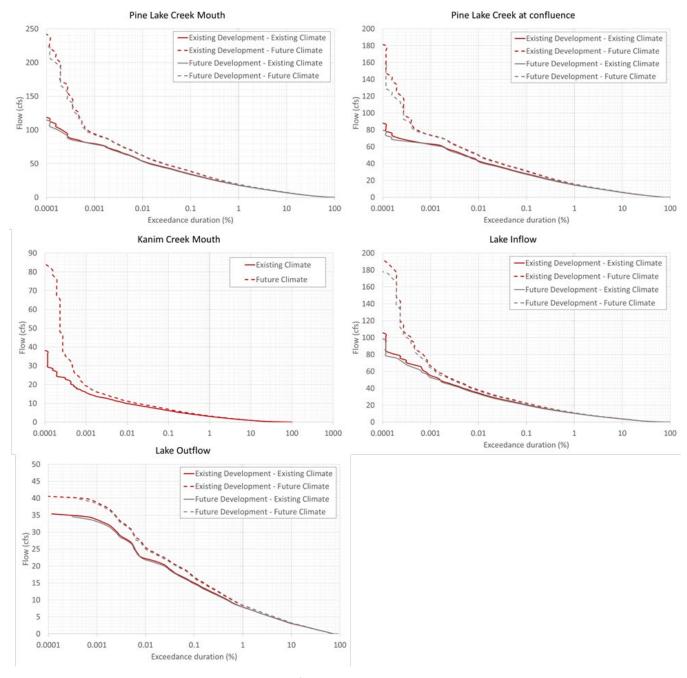
Figure 5.2 Flow duration curves. Note that no future development is expected in Kanim Creek so only existing development curves are shown.

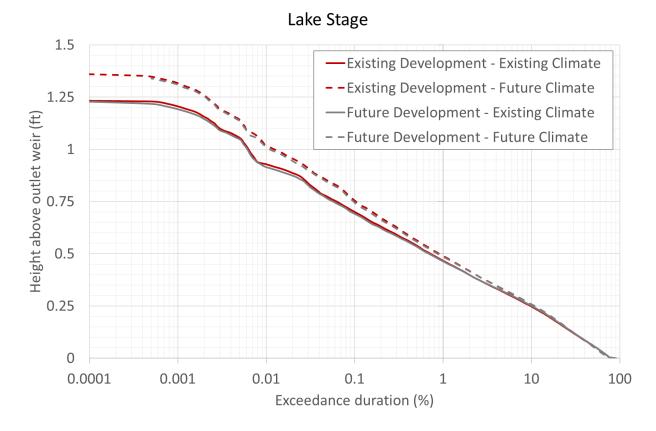
Figure 5.3 Pine Lake stage durations for different scenarios

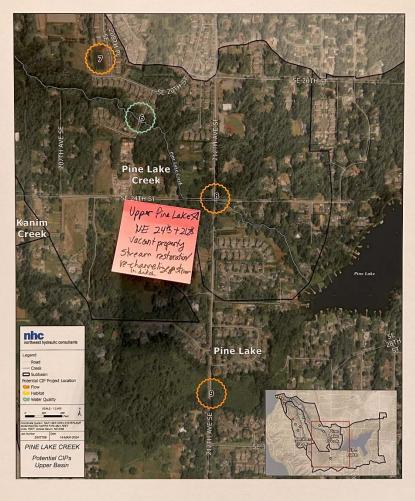
# POTENTIAL PINE LAKE CREEK PROJECTS (UPPER BASIN)

PROJECT #	PRIMARY BENEFIT	SECONDARY BENEFIT	PROJECT DESCRIPTION
6	Water Quality	Habitat	Remove sediment at bridge abutments.
7	Flow	Water Quality	Retrofit detention pond to increase flow control and accommodate future growth.
8	Flow	Habitat	Improve drainage in vicinity of 212th Ave SE and SE 24th St intersection.
9	Flow	Habitat	Expand conveyance to reduce road overtopping along 212th Ave SE.

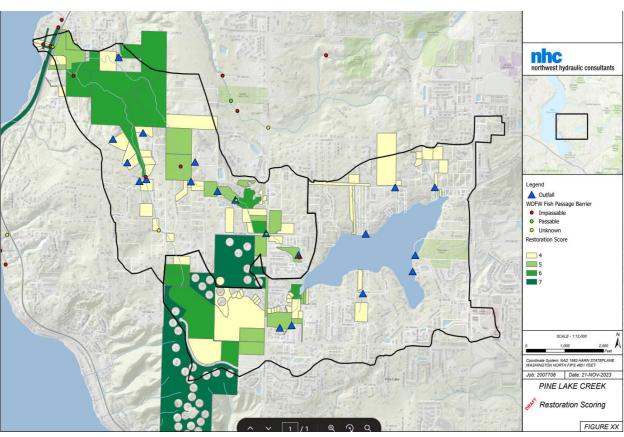
Figure F-1. Results of GIS-based Restoration Screening

An initial GIS screening was conducted using methodology developed in the retrofit strategy to determine parcels that would be appropriate for restoration or stormwater retrofit. The general methodology is outlined in the City of Sammamish Retrofit Strategy and Guidance Manual (Sammamish, 2021). Parcels were scored and ranked for restoration or retrofit potential. Figures F-1 and F-2 show the results of the parcel screening for restoration and retrofit, respectively.

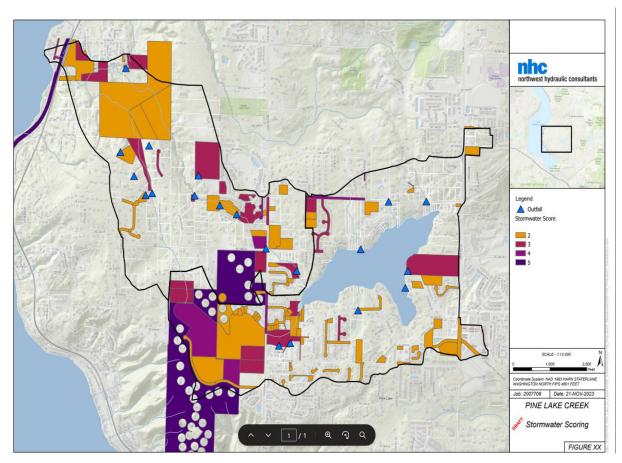
Figure F-2. Results of GIS-based Retrofit Potential Screening

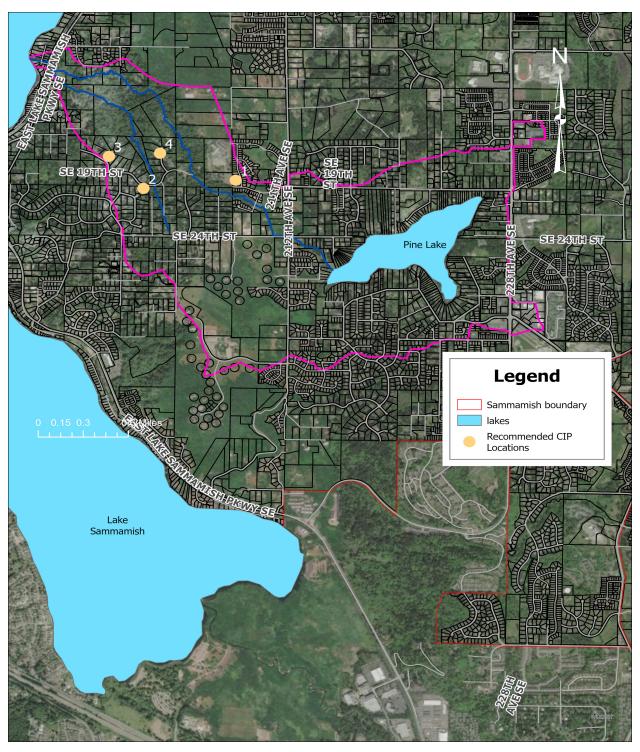
Figure F-3. Locations of Recommended Capital Projects

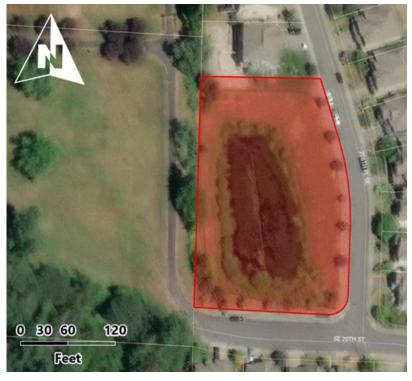
**Plan View**

Pond retrofit to improve detention, flow control, and water quality. There is an opportunity to expand the pond, which was built in 2000's prior to current flow control design standards.

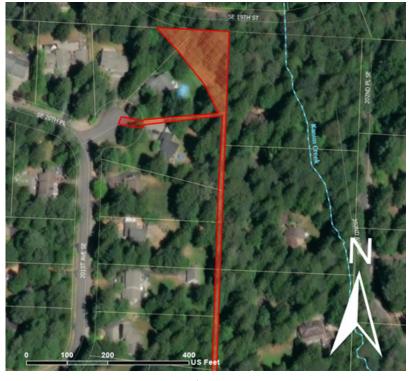
**Plan View**

Stormwater outfall has noticeable erosion and overflow, with downstream excessive peak flows. Updated detention infrastructure is proposed to reduce peak flows during storms, reduce erosion, and improve water quality.

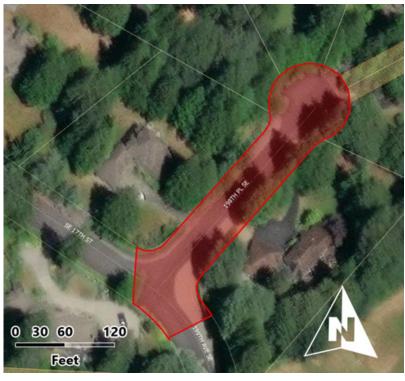
Plan View

This project retrofits the street edge with a bioswale. This bioswale will include foliage and rock to assist with erosion control along the shoulder, provide water quality treatment, and enhance the aesthetics of the street edge. Bioswale is designed to include detention to the extent feasible.

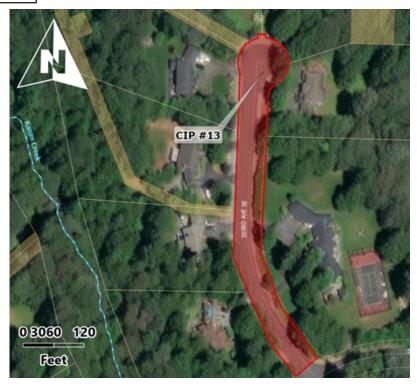
**Plan View**

This project retrofits the street edge for low impact development by including a bioswale. This bioswale will assist with erosion control along the shoulder, provide water quality treatment, and enhance the aesthetics of the street edge.
